Interim Measures Investigation Report

**EXIDE ENVIRONMENTAL RESPONSE TRUST
Frankfort Indiana Site
555 North Hoke Avenue
EPA ID No. IND001647460**

Prepared: April 29, 2022

Montrose Project # 2020-4123-02

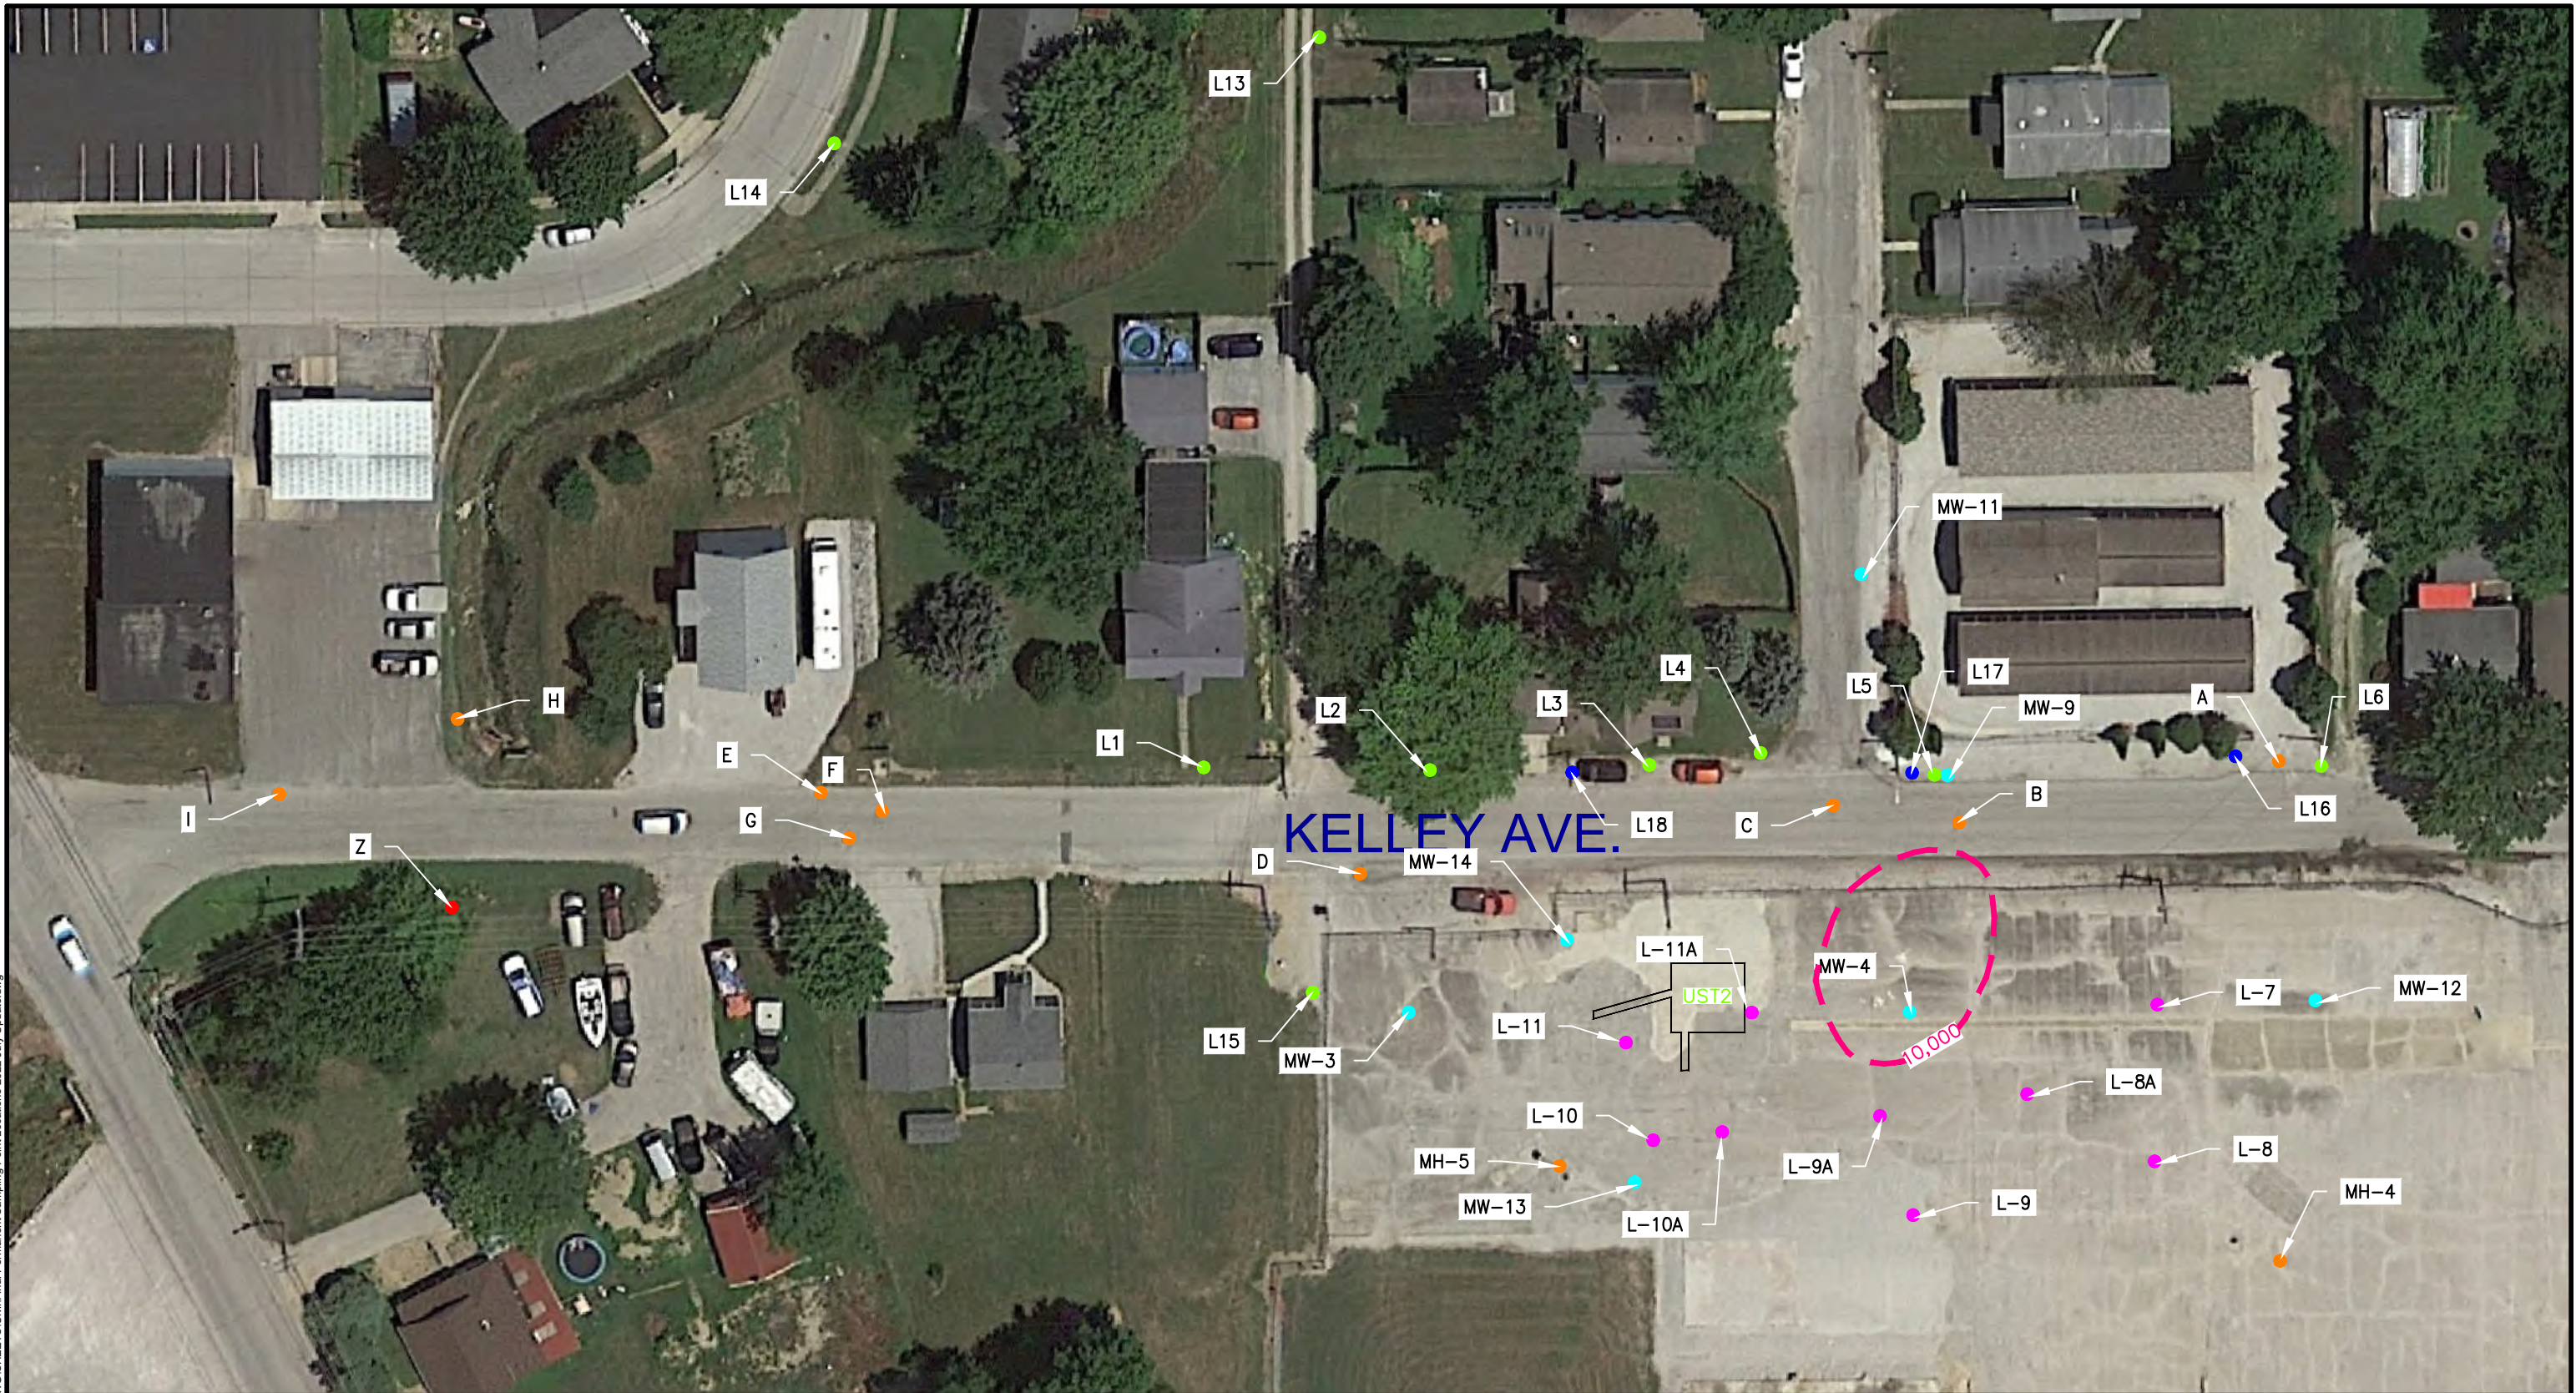
EXIDE TECHNOLOGIES 555 HOKE AVENUE FRANKFORT, INDIANA																			
PERMANENT GROUNDWATER AND SOIL VAPOR SAMPLING POINTS																			
<p>ADVANCED Geoservices</p> <p>A MONTROSE ENVIRONMENTAL GROUP COMPANY 1055 ANDREW DRIVE, SUITE A WEST CHESTER, PENNSYLVANIA 19380 Tel: 610.840.9100 Fax: 610.840.9199 Web: www.advancedgeoservices.com</p>

One stormwater outfall location is present along Kelley Ave. north of the Site. This outfall (designated Outfall Location Z on Figures 2 and 9) was observed to be flowing on October 19, 2021. A sample of the water was collected for VOC and Lead analysis. Additionally, a soil sample from the unnamed tributary the outfall pipe drains to was collected for VOCs and Lead analysis. Samples from the outfall (water and sediment) were relinquished to Pace – Indianapolis for analysis.

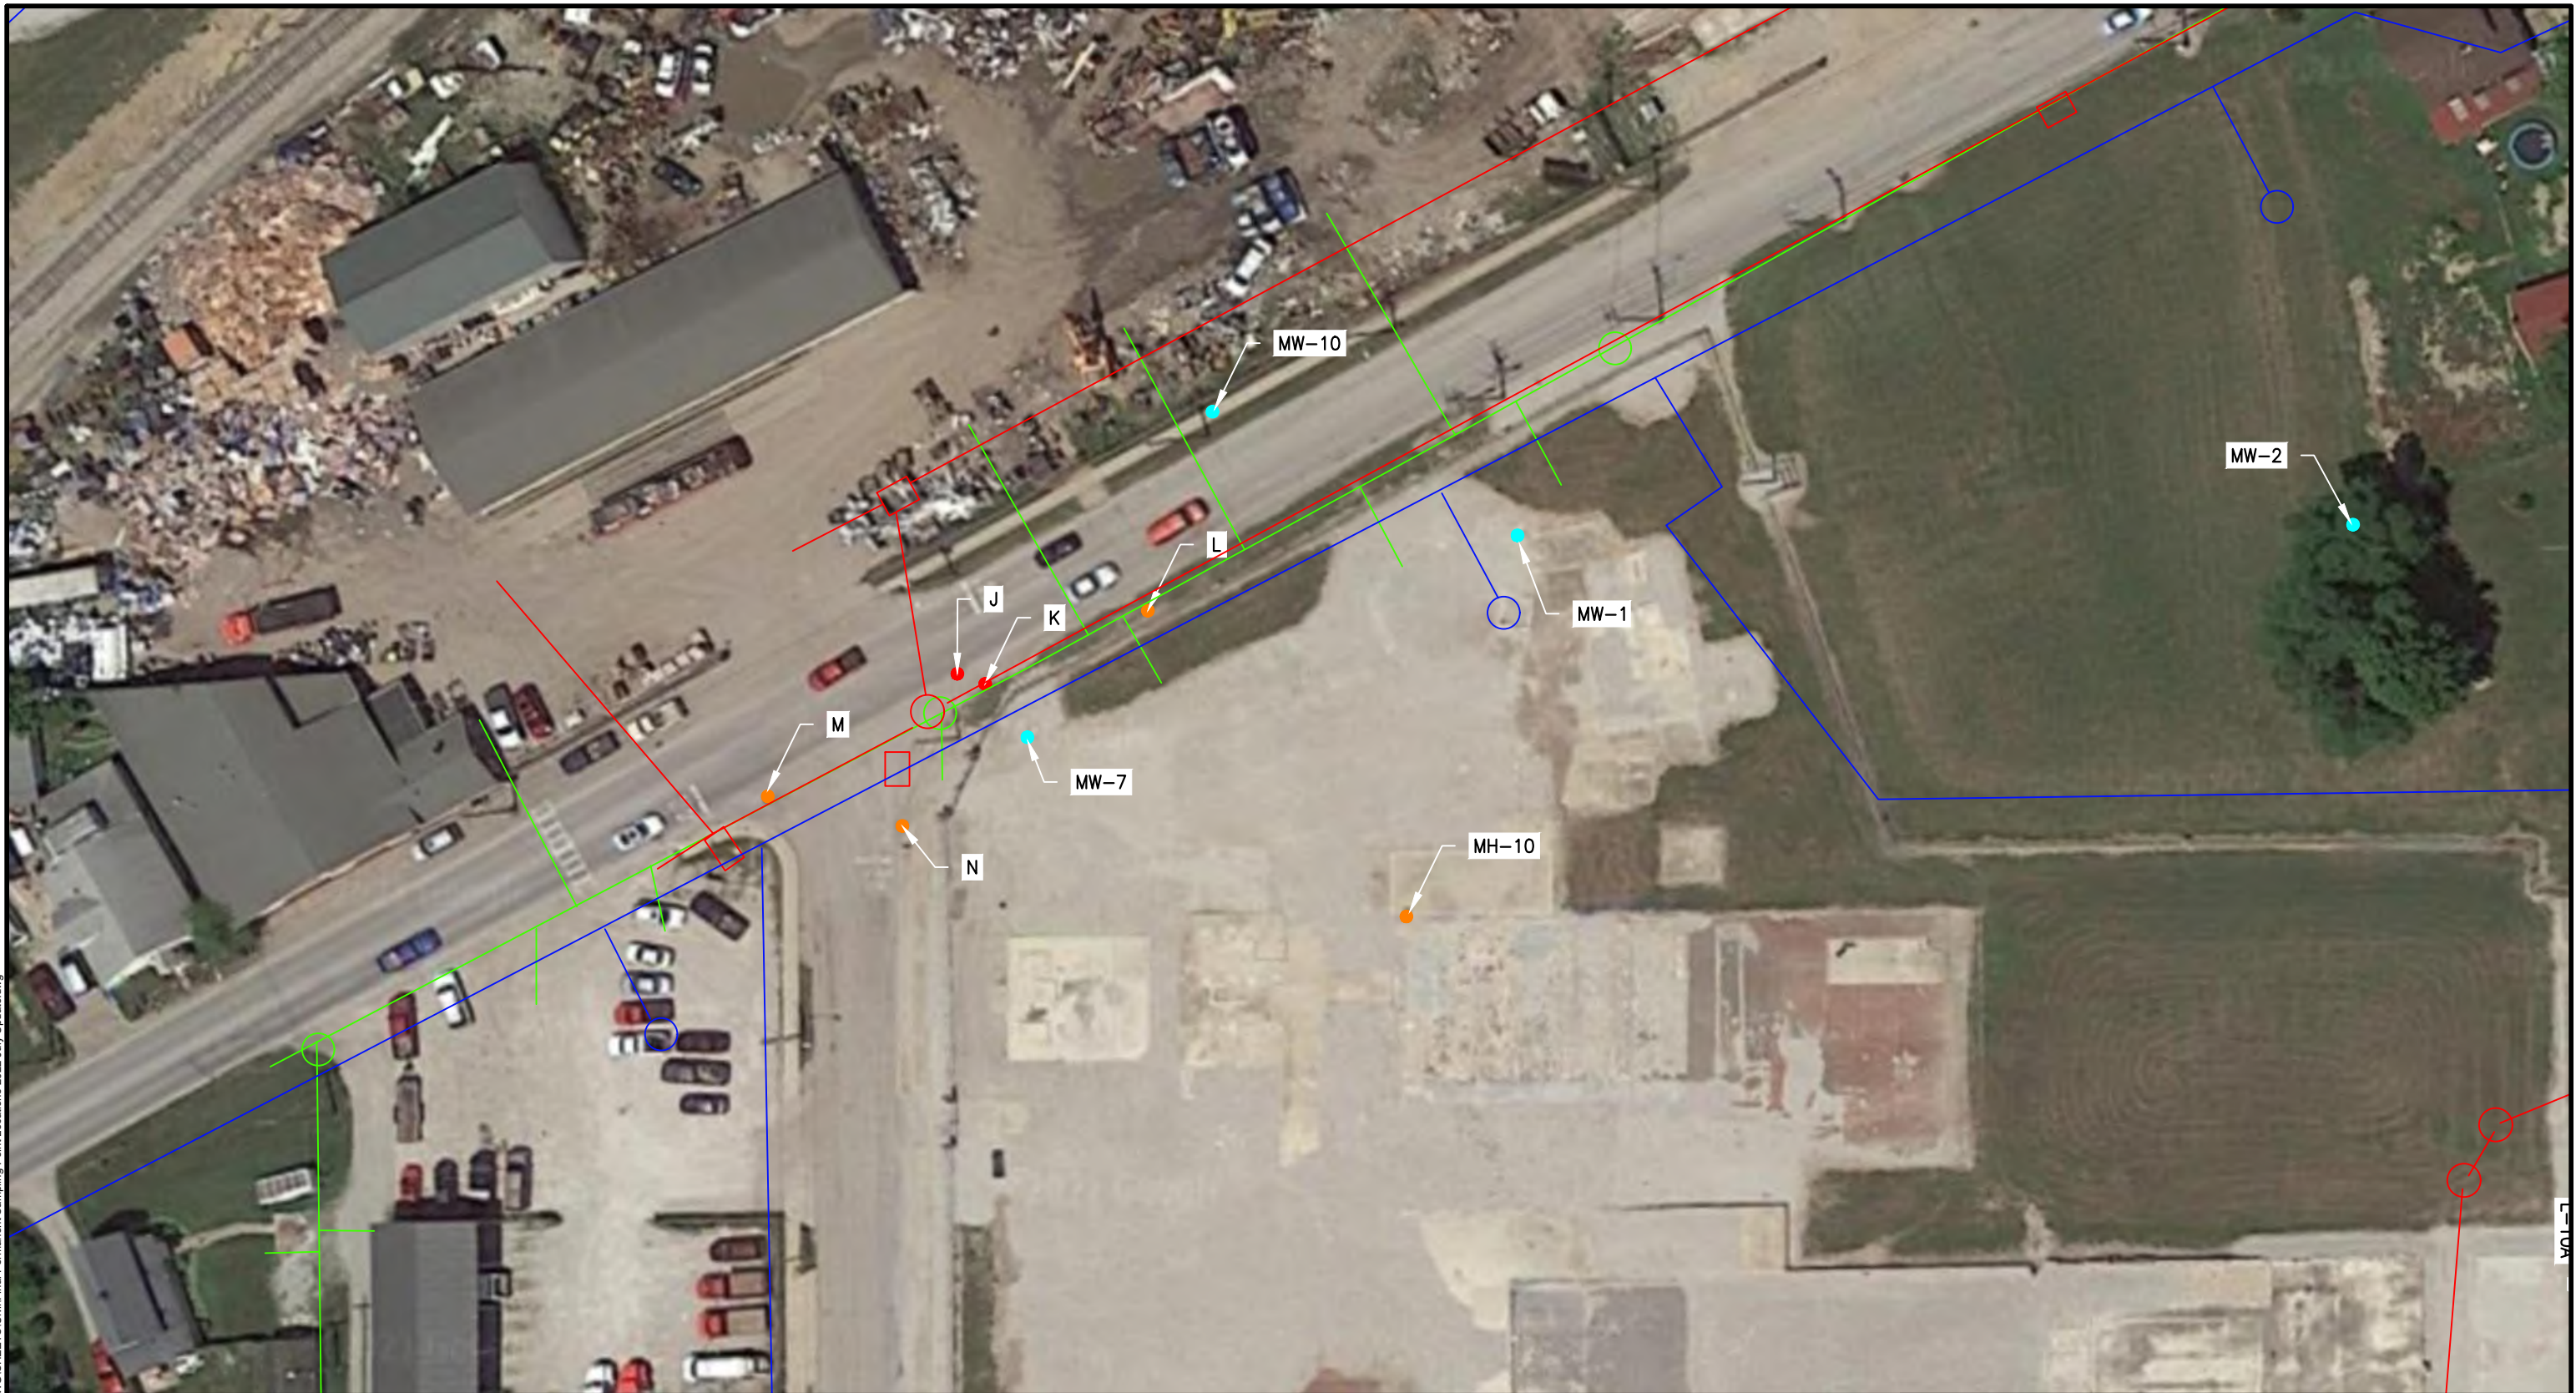
NOTE: LINE LOCATIONS ARE APPROXIMATE AND TAKEN FROM MAPS PROVIDED BY THE CITY OF FRANKFORT'S MUNICIPAL UTILITY SUPERINTENDENTS.

EXIDE TECHNOLOGIES 555 HOKE AVENUE FRANKFORT, INDIANA																			
PROPOSED MANHOLE VAPOR WASHINGTON AVENUE LOCATIONS																			
<p style="font-size: small; margin-top: 5px;"> A MONTROSE ENVIRONMENTAL GROUP COMPANY 1055 ANDREW DRIVE, SUITE A WEST CHESTER, PENNSYLVANIA 19380 Tel: 610.840.9100 Fax: 610.840.9199 Web: www.advancedgeoservices.com </p>

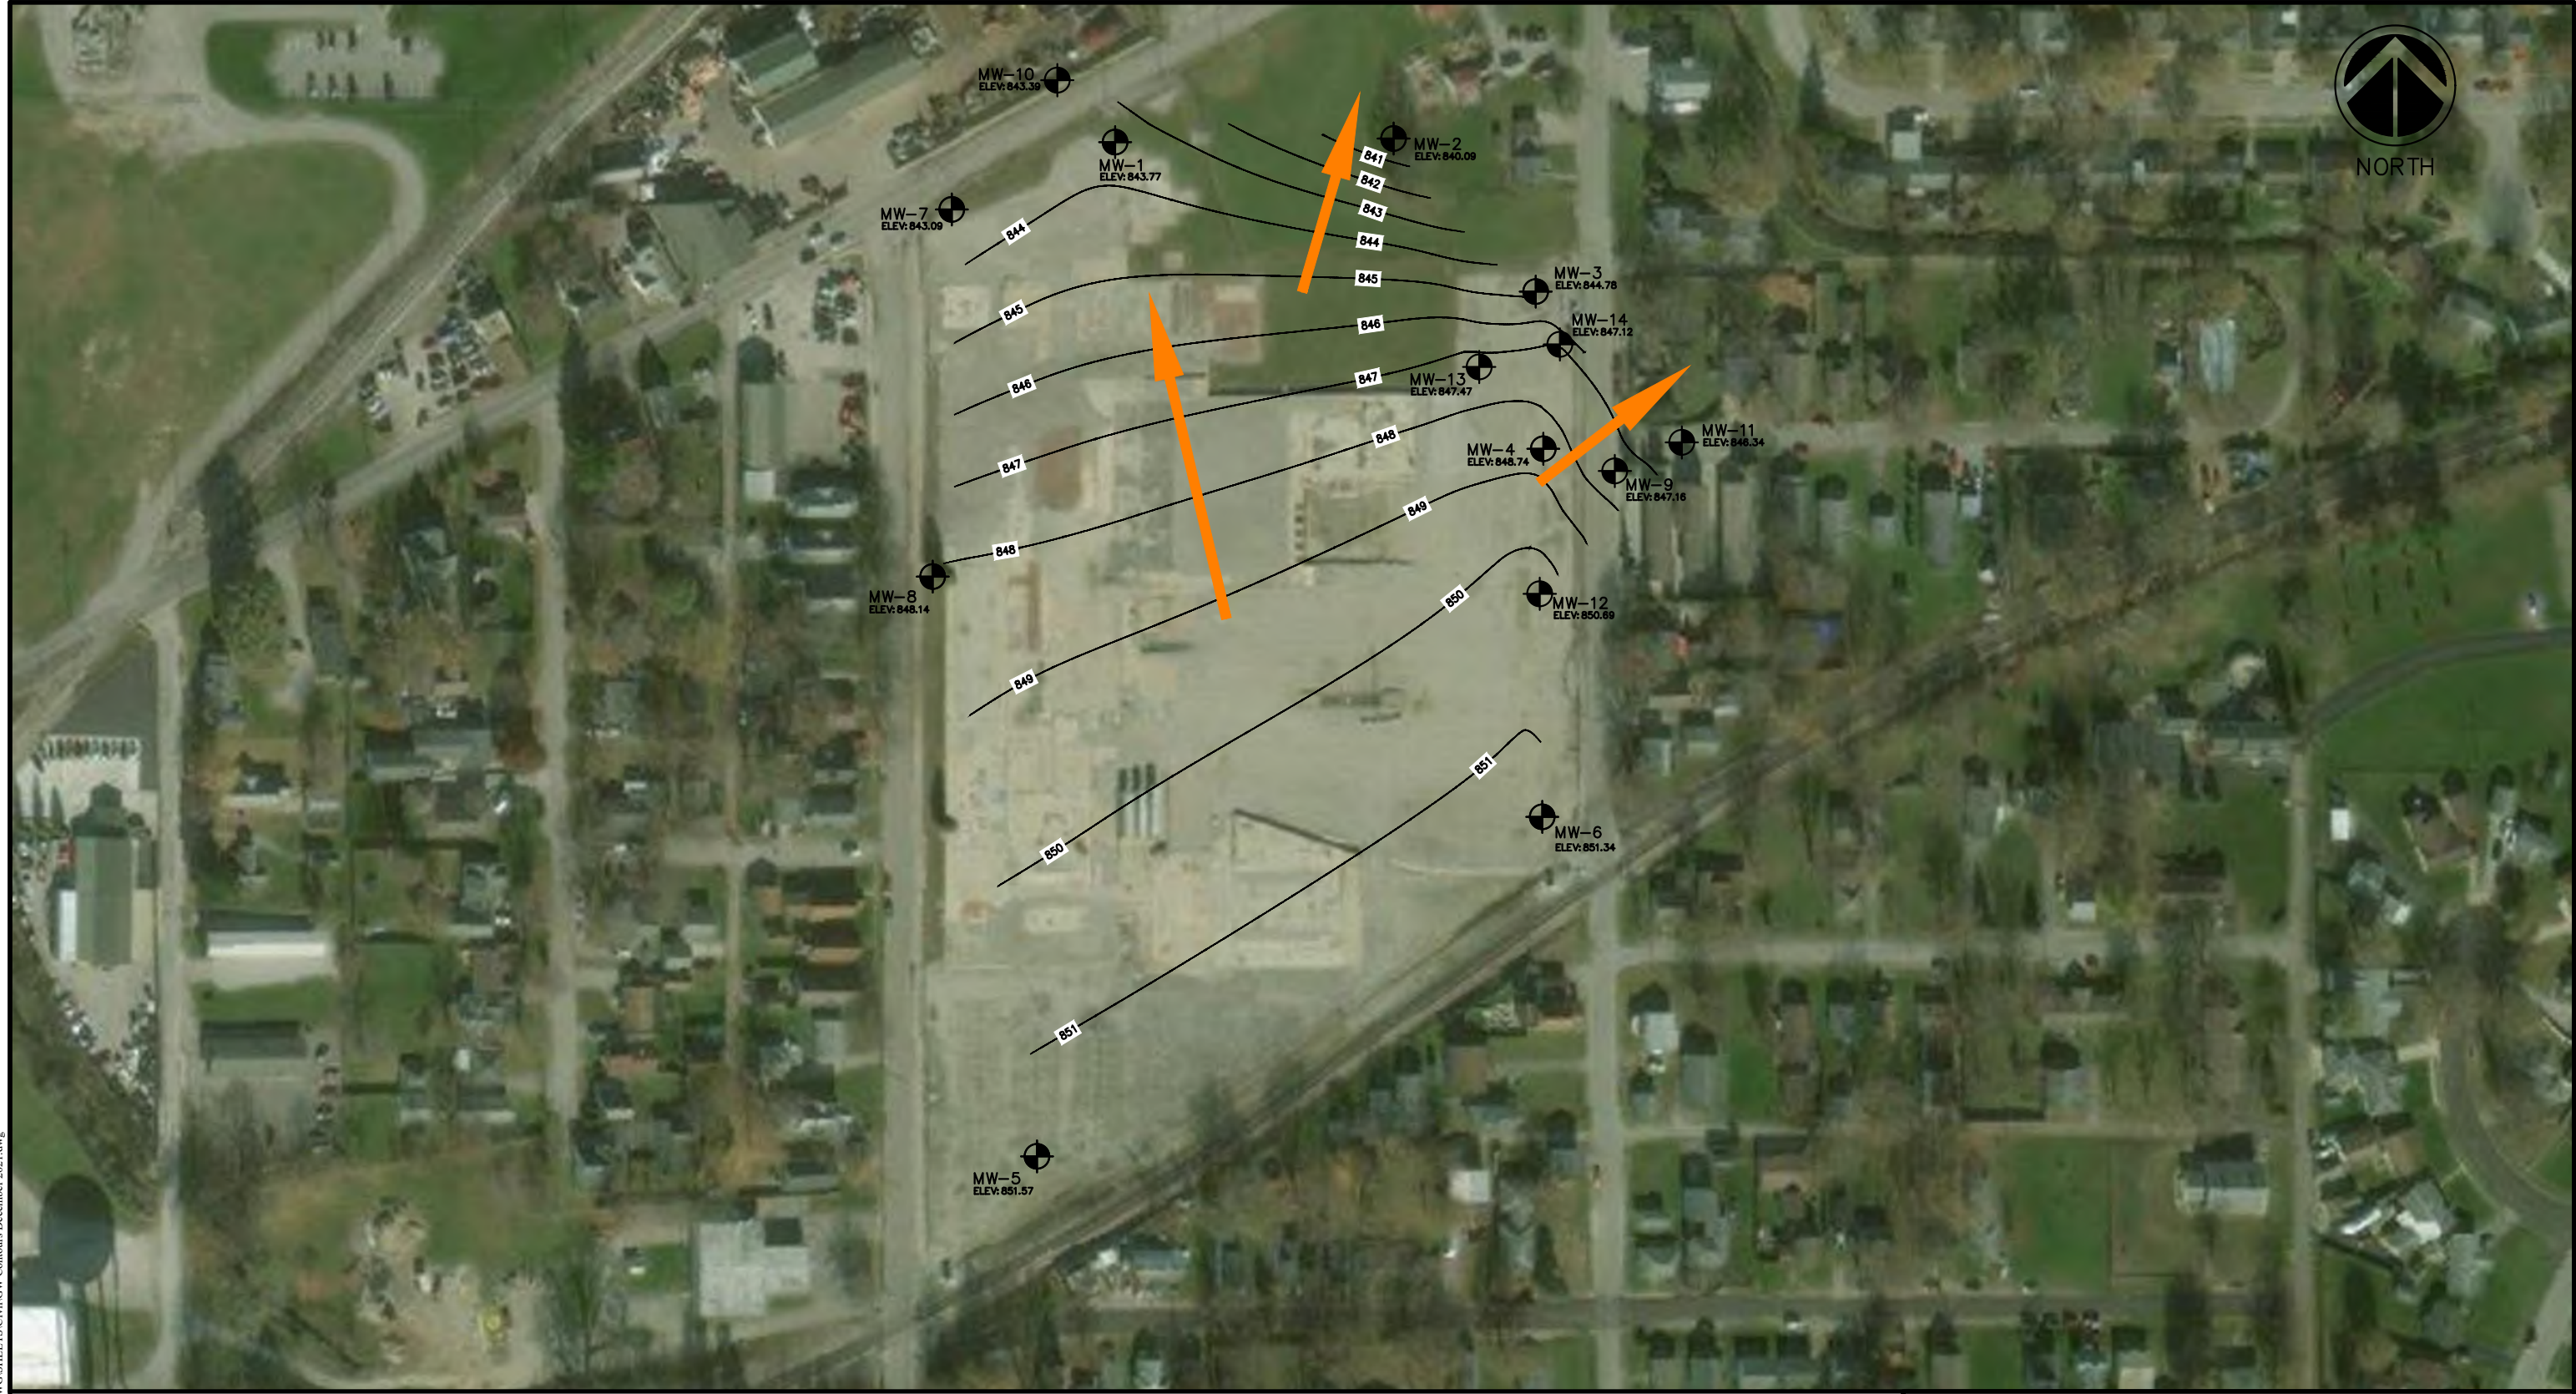
FIGURE 3

- GROUNDWATER FLOW DIRECTION
- GROUNDWATER CONTOURS
- MONITORING WELL

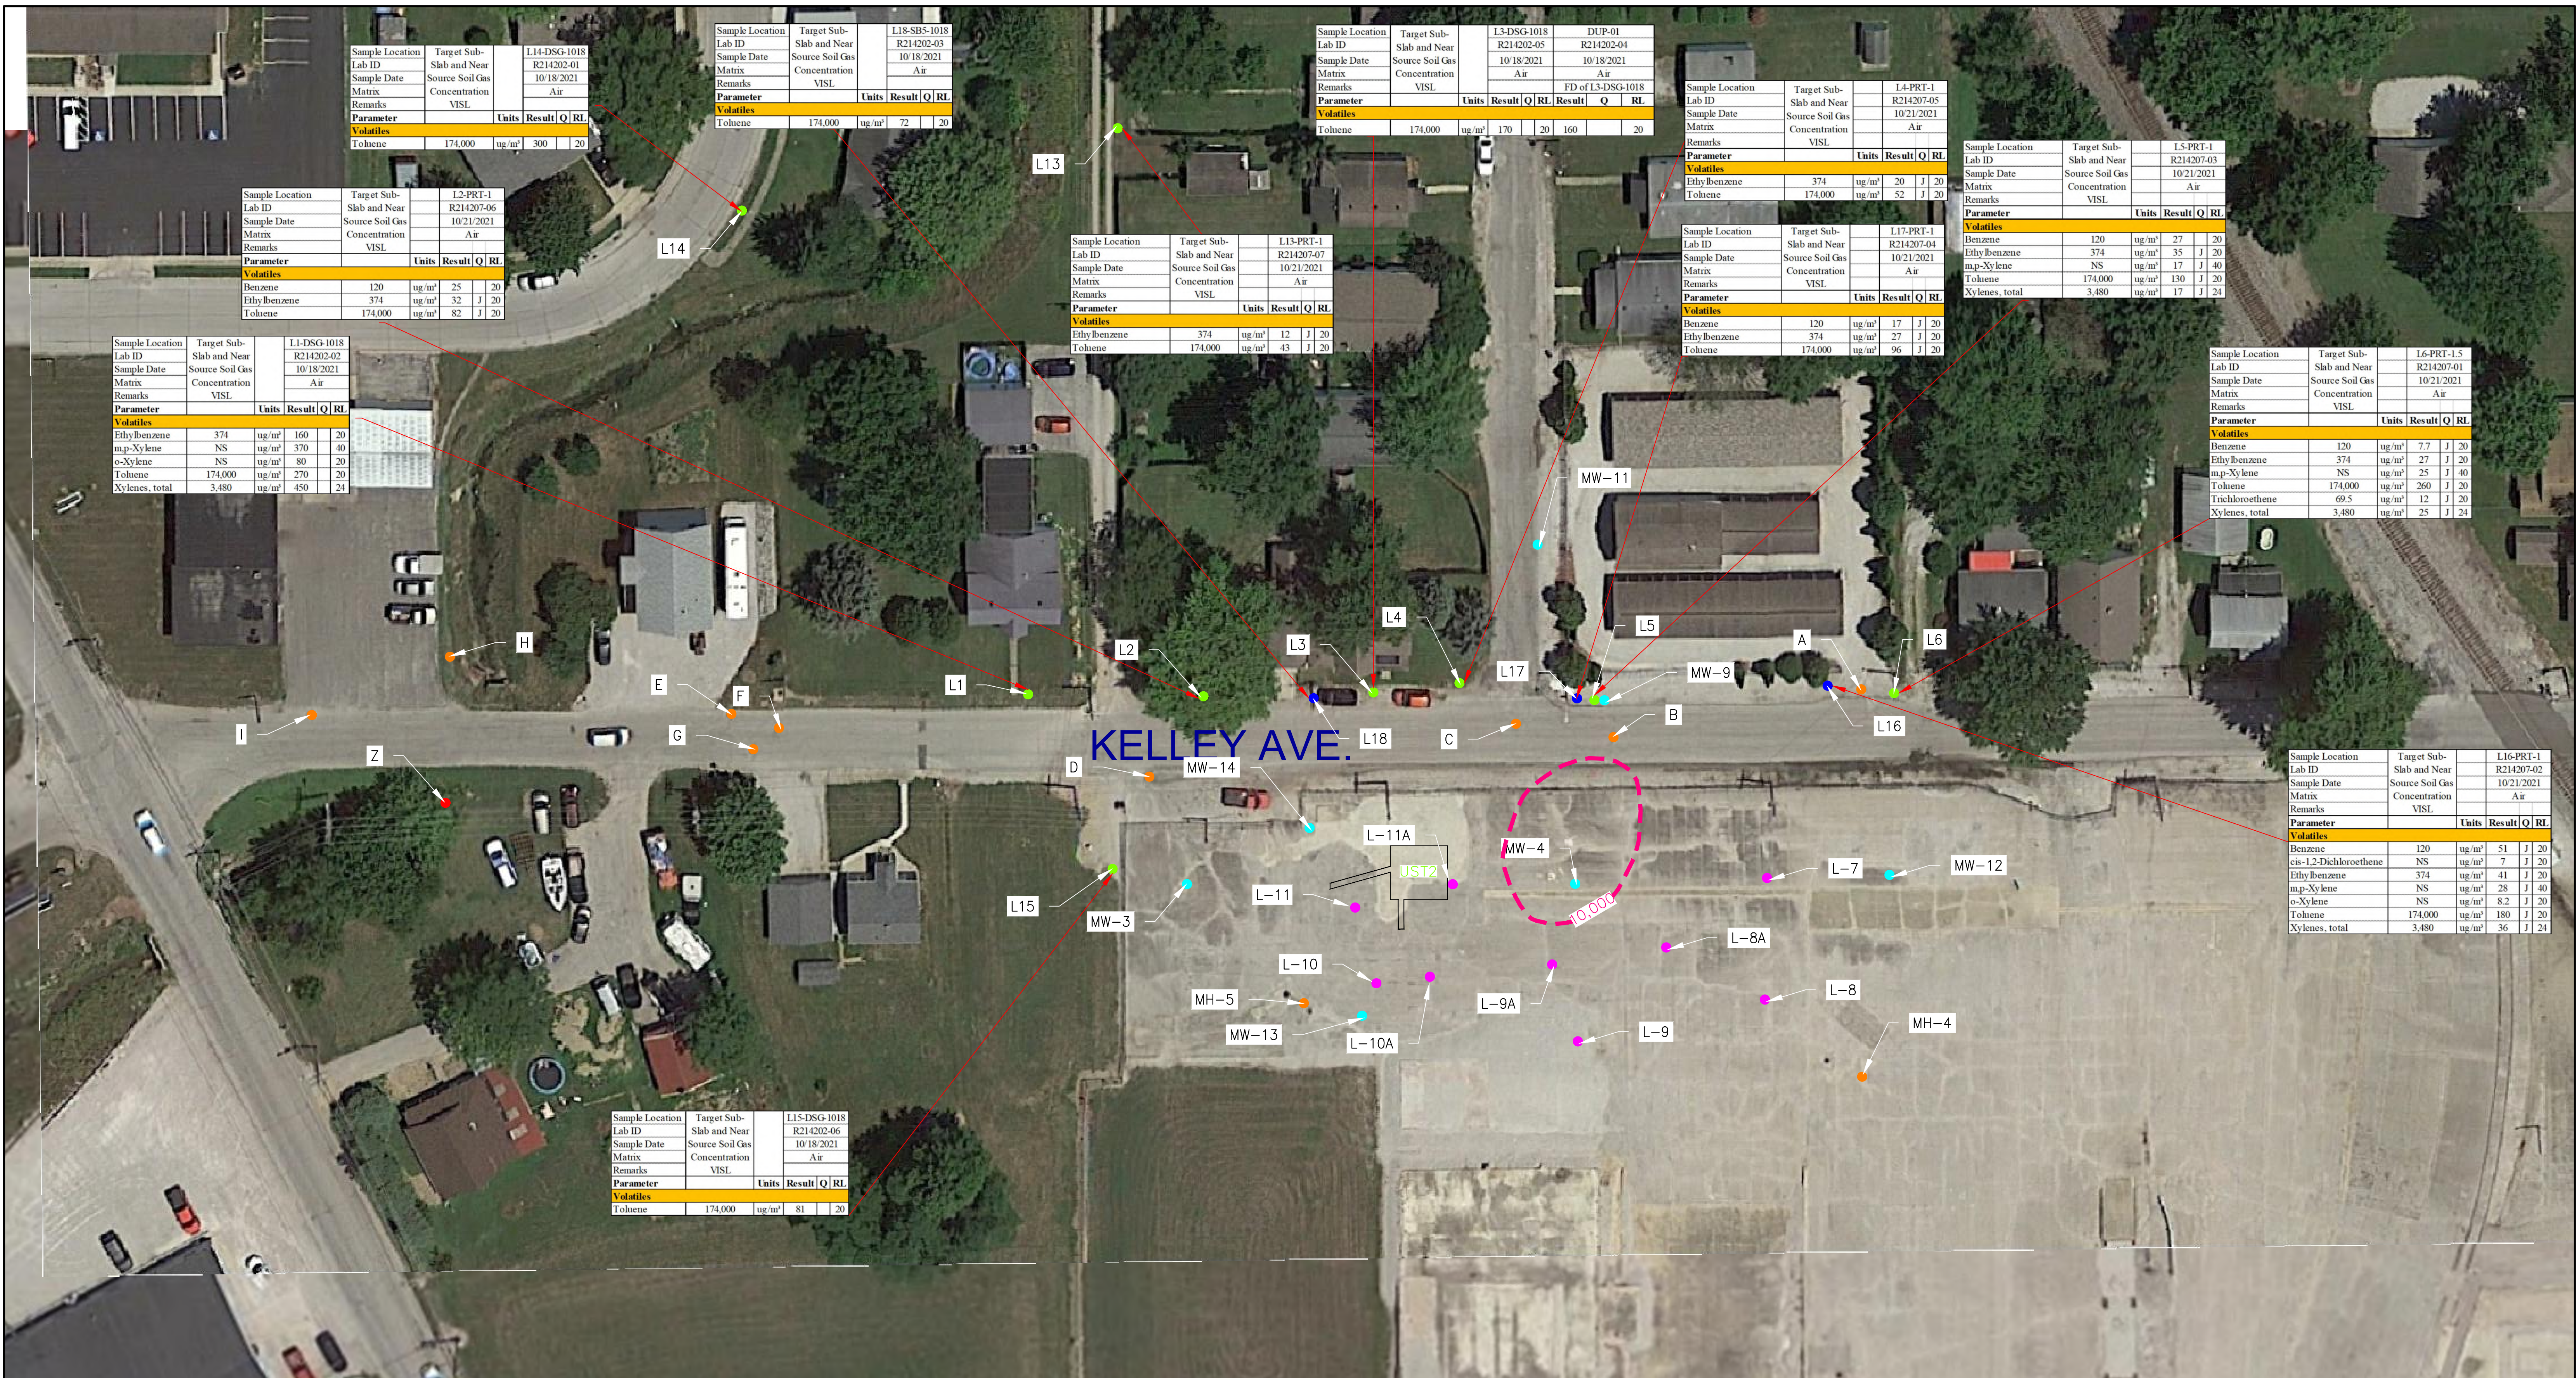
FIGURE 8

NOTES:
 1. SOIL GAS SAMPLES WERE ANALYZED FOR BTEX, CIS-1,2-DCE, PCE, TCE, AND VC USING A FIELD GC OPERATED BY PACE ANALYTICAL.
 2. ANALYTES NOT DETECTED AT OR ABOVE THE METHOD DETECTION LIMIT ARE NOT SHOWN.
 3. ALL RESULTS SHOWN IN UG/M3 - MICROGRAM PER CUBIC METER
 4. THE RESULTS INDICATE NO EXCEEDANCES OF THE TARGET SUB-SLAB AND NEAR SOURCE SOIL GAS CONCENTRATION VISL
 5. VISL - VAPOR INTRUSION SCREENING LEVEL
 6. DSG - DEEP SOIL SAMPLE (3-4 FEET BELOW GRADE)
 7. PRT - GEOPROBE POST RUN TUBING (1 - 1.5 FEET BELOW GRADE)
 8. SBS - SEWER BED SAMPLE (L16, L17, L18)
 9. J - DENOTES AN ESTIMATED REPORTING LIMIT
 10. Q - QUALIFIER
 11. RL - REPORTING LIMIT
 12. NS - NO STANDARD AVAILABLE FOR THE COMPOUND
 13. FD - FIELD DUPLICATE

Number:	Date:	Revision:
EXIDE TECHNOLOGIES 555 HOKE AVENUE FRANFORT, INDIANA		
SOIL VAPOR SAMPLING RESULTS		
ADVANCED GeoServices		Scale: 1" = 30'
A MONTRORSE ENVIRONMENTAL GROUP COMPANY 1055 ANDREW DRIVE, SUITE A WEST CHESTER, PENNSYLVANIA 19380 Tel: 610.840.9100 Fax: 610.840.9199 Web: www.advancedgeoservices.com		Drawn By: MCB Checked By: GS Project Mgr: PGS Originated By: GS Project No.: 2020-4123 Drawing Date: AUGUST 2021 Sheet No.: 0F Revision Number: 0

A total of twelve (12) soil gas samples were collected and analyzed for BTEX, cis-1,2-DCE, PCE, TCE, and VC using a field GC operated by Pace Analytical. Locations L1, L3, L14, L15, and L18 were collected from soil vapor pins (after helium leak testing) and the results are shown on Table 11. A duplicate sample was taken of L3. Geoprobe PRT system of sample collection was used to collect soil gas samples at a depth of 1.5 feet at locations L2, L4, L5, L6, L13, L16, and 17. Figure 8 shows the locations of the soil gas sampling and any positive detections. The results are shown on Table 12. The results on Table 11 and Table 12 indicate no exceedances of the Target Sub-Slab and Near Source Soil Gas Concentration VISL.

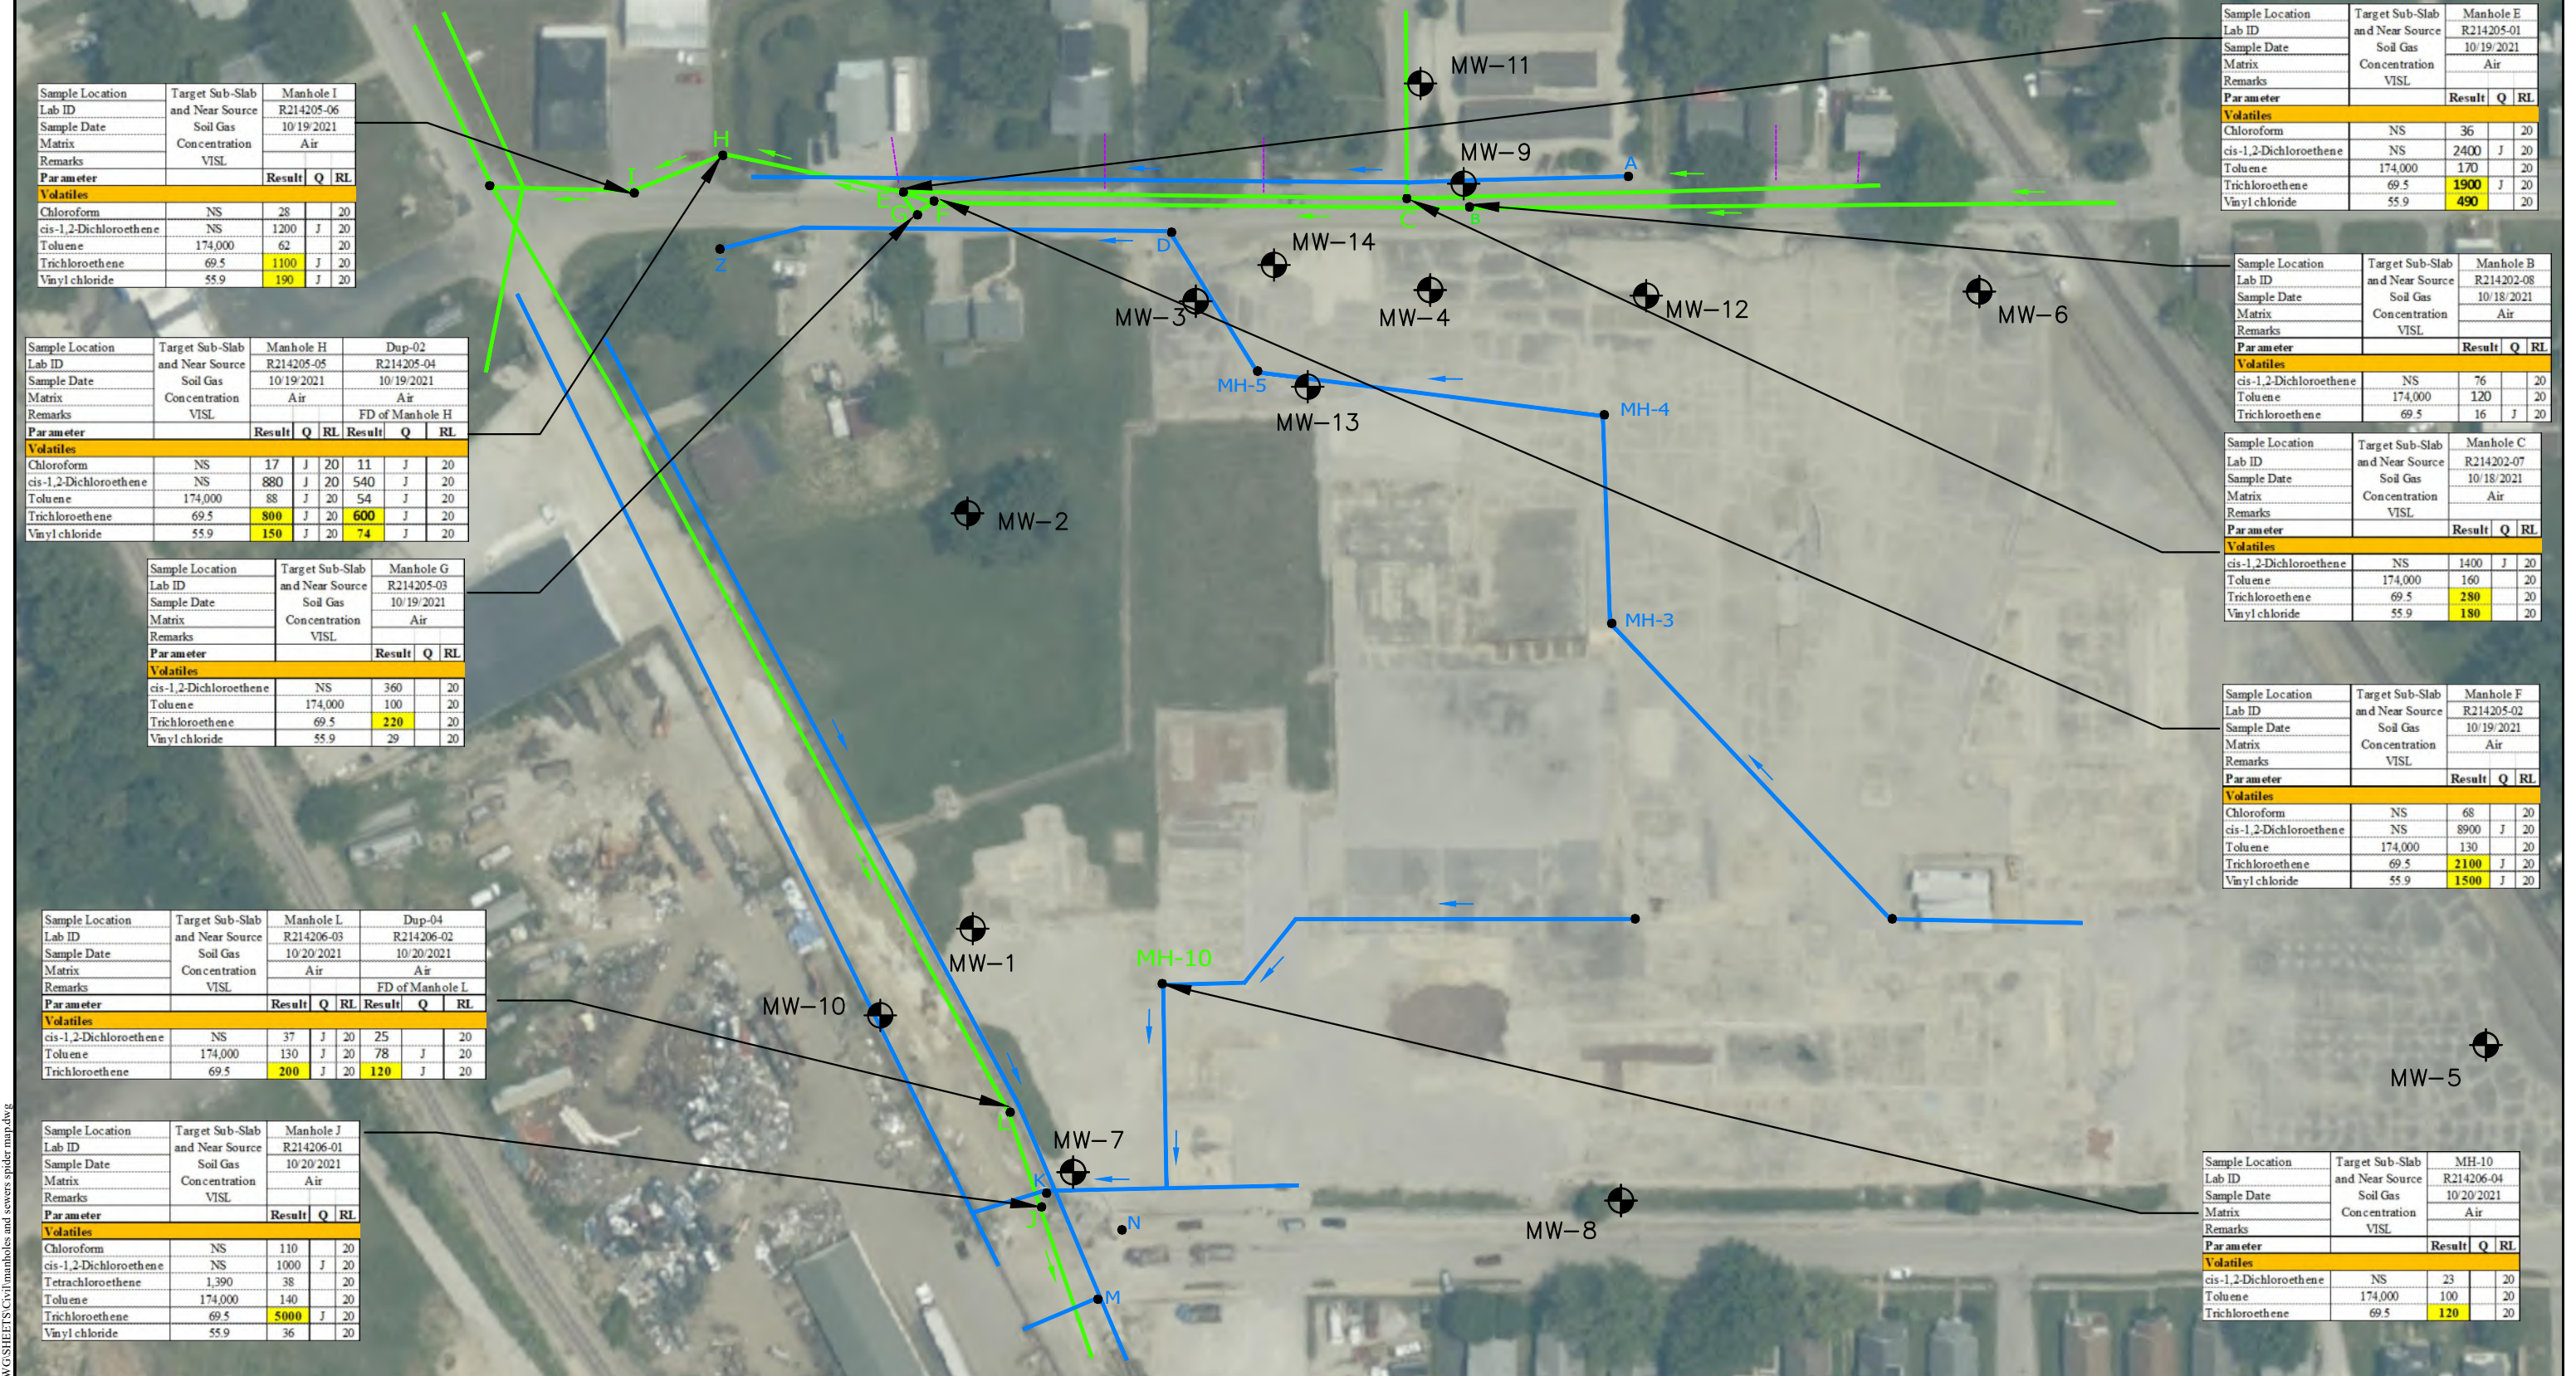
- NOTE**
- UTILITY LINE LOCATIONS INFERRED FROM FIELD MEASUREMENTS AND DRAWINGS PROVIDED BY FRANKFORT UTILITY DEPARTMENTS AND SURVEY DATA COLLECTED BY RANDALL MILLER ASSOCIATES.
 - MANHOLE VAPOR SAMPLES WERE ANALYZED FOR BTEX, CIS-1,2-DCE, PCE, TCE, AND VC USING A FIELD GC OPERATED BY PACE ANALYTICAL.
 - ANALYTES NOT DETECTED AT OR ABOVE THE METHOD DETECTION LIMIT ARE NOT SHOWN.
 - ALL RESULTS SHOWN IN UG/M3 - MICROGRAM PER CUBIC METER.
 - BOLDING AND SHADING INDICATES EXCEEDANCES OF THE TARGET SUB-SLAB AND NEAR SOURCE SOIL GAS CONCENTRATION VISL.
 - VISL - VAPOR INTRUSION SCREENING LEVEL.
 - J - DENOTES AN ESTIMATED REPORTING LIMIT.
 - Q - QUALIFIER.
 - RL - REPORTING LIMIT.
 - NS - NO STANDARD AVAILABLE FOR THE COMPOUND.
 - FD - FIELD DUPLICATE.

The ten (10) manhole sample results are shown on Table 13. The manholes are designated as Manhole B, C, E, F, G, H, I, J, L, and MH-10. All of the ten sampled manholes were found to exceed the Target Sub-Slab and Near Source Soil Gas Concentration VISL for TCE (69.5 ug/m³). Additionally, five of the ten sampled manholes exceeded the VISL for VC (55.9 ug/m³). All manholes had detectable concentrations of DCE ranging from 23 to 8,900 ug/m³. Other compounds detected in at least one manhole sample include Chloroform, Tetrachloroethene, and Toluene.

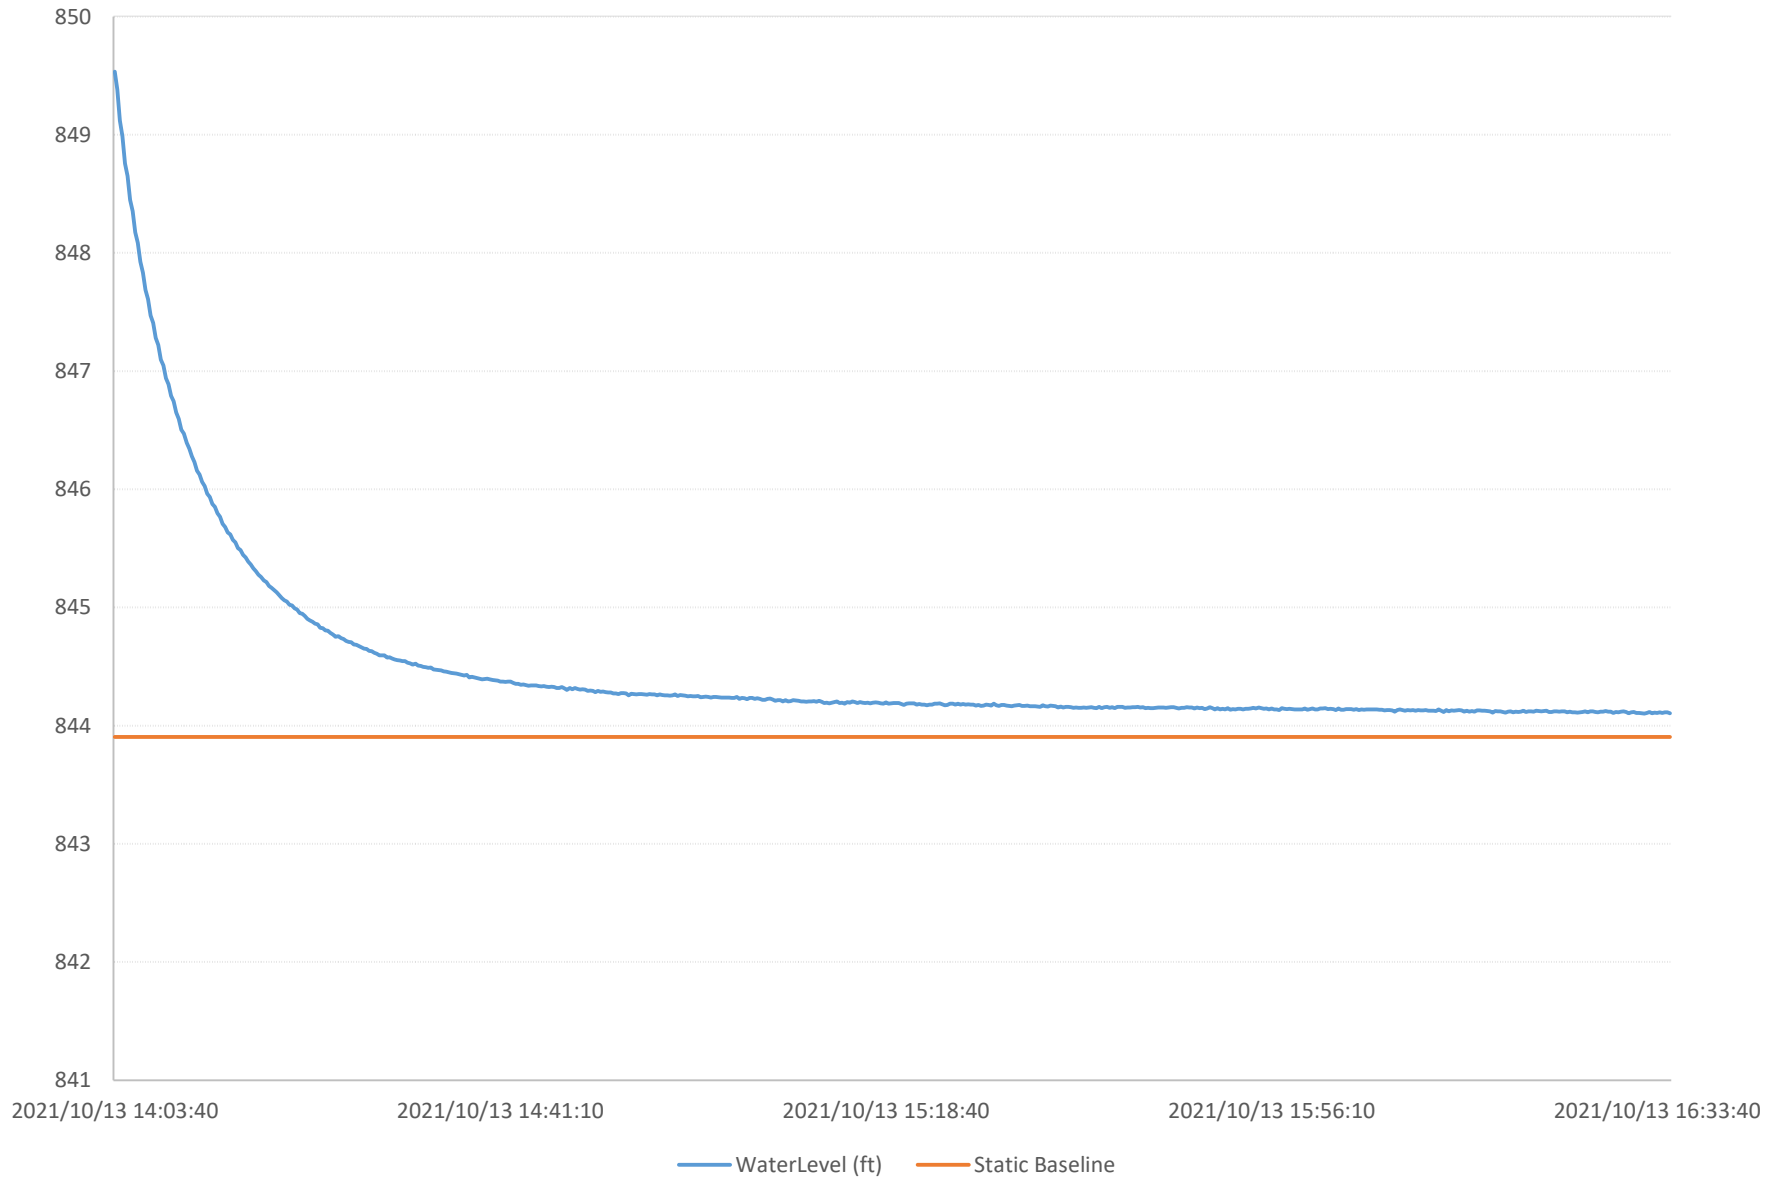
FIGURE ____
SLUG TEST DATA
MW-1
Exide Technologies
Frankfort, Indiana

A K value for each well was calculated using the USGS published Spreadsheets for the Analysis of Aquifer-Test and Slug-Test Data by Halford and Kuniandy (2002). This spreadsheet uses the Bouwer and Rice (1976) modeling to calculate the K value. During the analysis, it was found that the use of a 5 second data collection interval resulted in a significant amount of data (over 17,000 data points per well), while the spreadsheet used is only capable of analyzing 600 data points. Therefore, the data was systematically reduced by Montrose to focus on the first three hours of the testing when the well had regained 80% of its initial static level during that time. One well (MW-7) took a longer period than the other wells to regain this level, therefore additional points collected at an hourly or bihourly interval for the remaining time period (i.e., beyond the initial three hours) were incorporated into the data set for the calculation of the hydraulic conductivity (K) value for this well. The final summary sheet produced by the spreadsheet and a data plot for each well is presented in Appendix C. Calculated hydraulic conductivities range from 0.0004 to 0.0088 and are summarized on Table 3. The values are consistent with glacial till.
