Interim Measures Investigation Report

**EXIDE ENVIRONMENTAL RESPONSE TRUST
Frankfort Indiana Site
555 North Hoke Avenue
EPA ID No. IND001647460**

Prepared: April 29, 2022

Montrose Project # 2020-4123-02

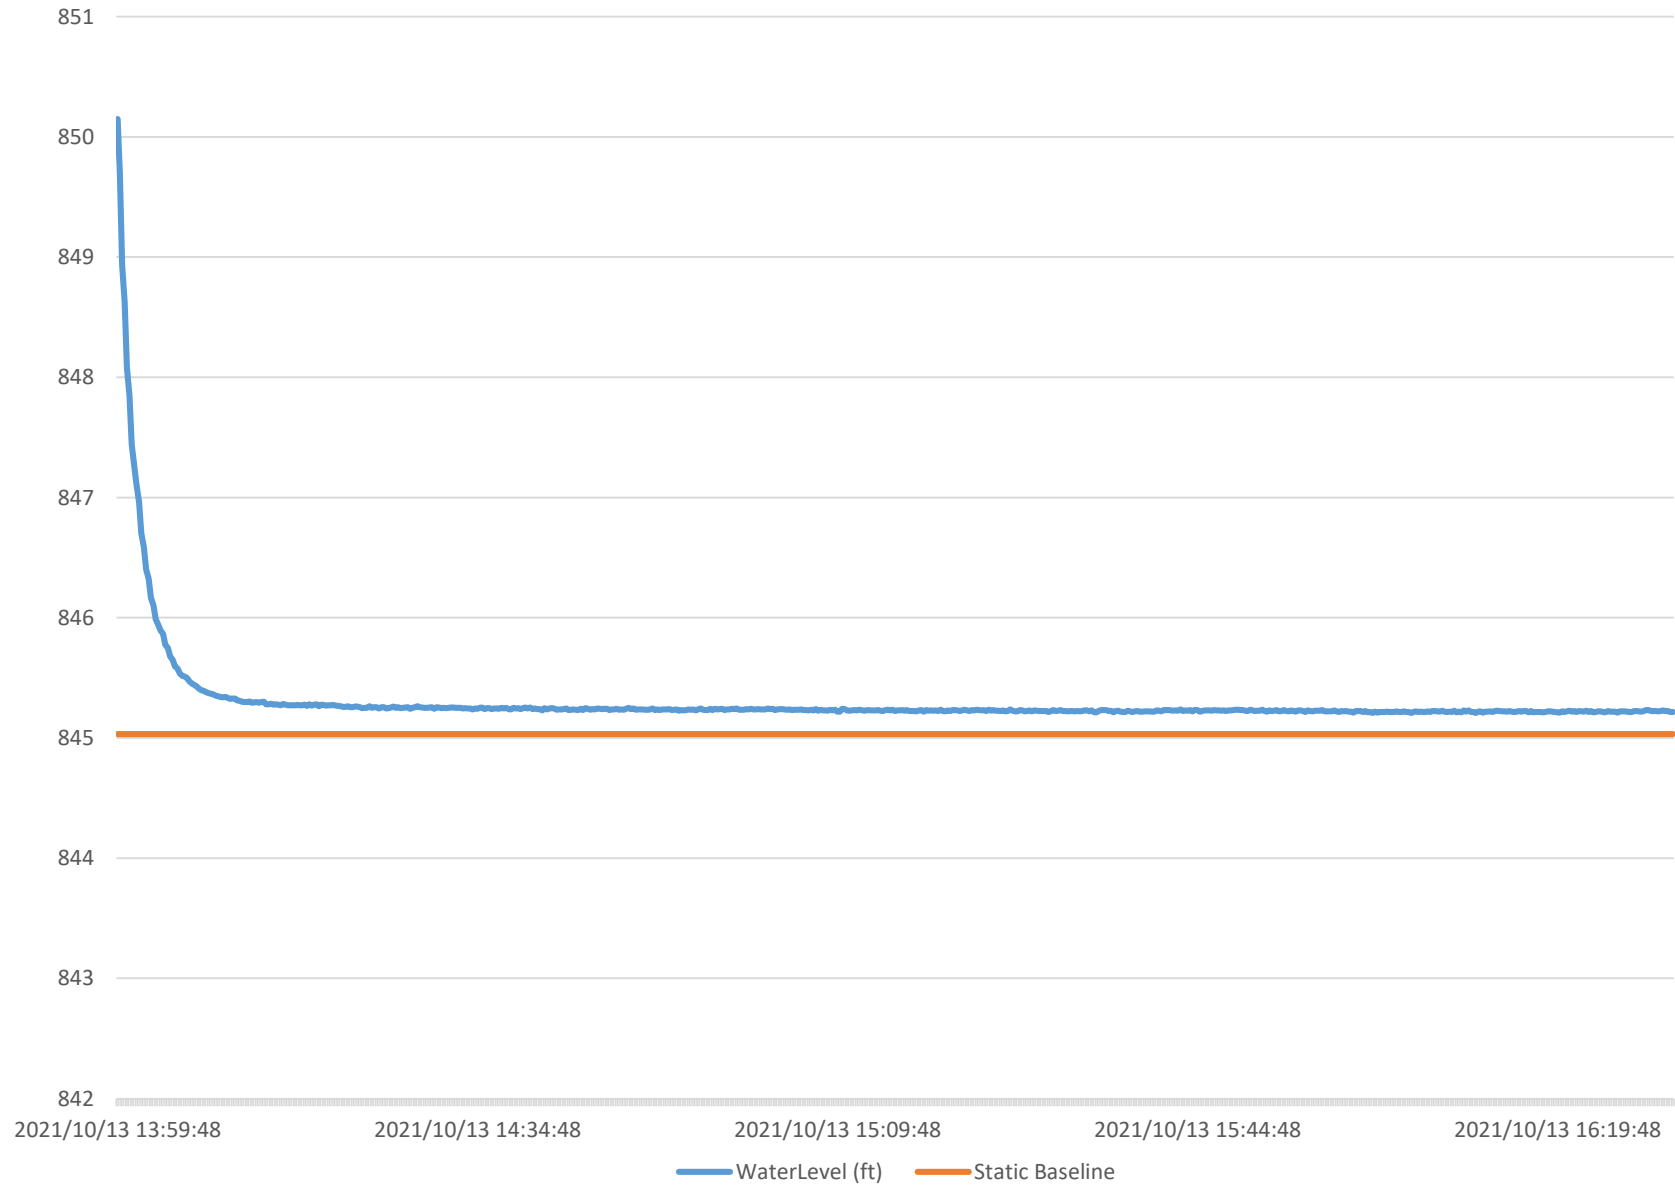
FIGURE ____
SLUG TEST DATA
MW-3
Exide Technologies
Frankfort, Indiana

A K value for each well was calculated using the USGS published Spreadsheets for the Analysis of Aquifer-Test and Slug-Test Data by Halford and Kuniandy (2002). This spreadsheet uses the Bouwer and Rice (1976) modeling to calculate the K value. During the analysis, it was found that the use of a 5 second data collection interval resulted in a significant amount of data (over 17,000 data points per well), while the spreadsheet used is only capable of analyzing 600 data points. Therefore, the data was systematically reduced by Montrose to focus on the first three hours of the testing when the well had regained 80% of its initial static level during that time. One well (MW-7) took a longer period than the other wells to regain this level, therefore additional points collected at an hourly or bihourly interval for the remaining time period (i.e., beyond the initial three hours) were incorporated into the data set for the calculation of the hydraulic conductivity (K) value for this well. The final summary sheet produced by the spreadsheet and a data plot for each well is presented in Appendix C. Calculated hydraulic conductivities range from 0.0004 to 0.0088 and are summarized on Table 3. The values are consistent with glacial till.

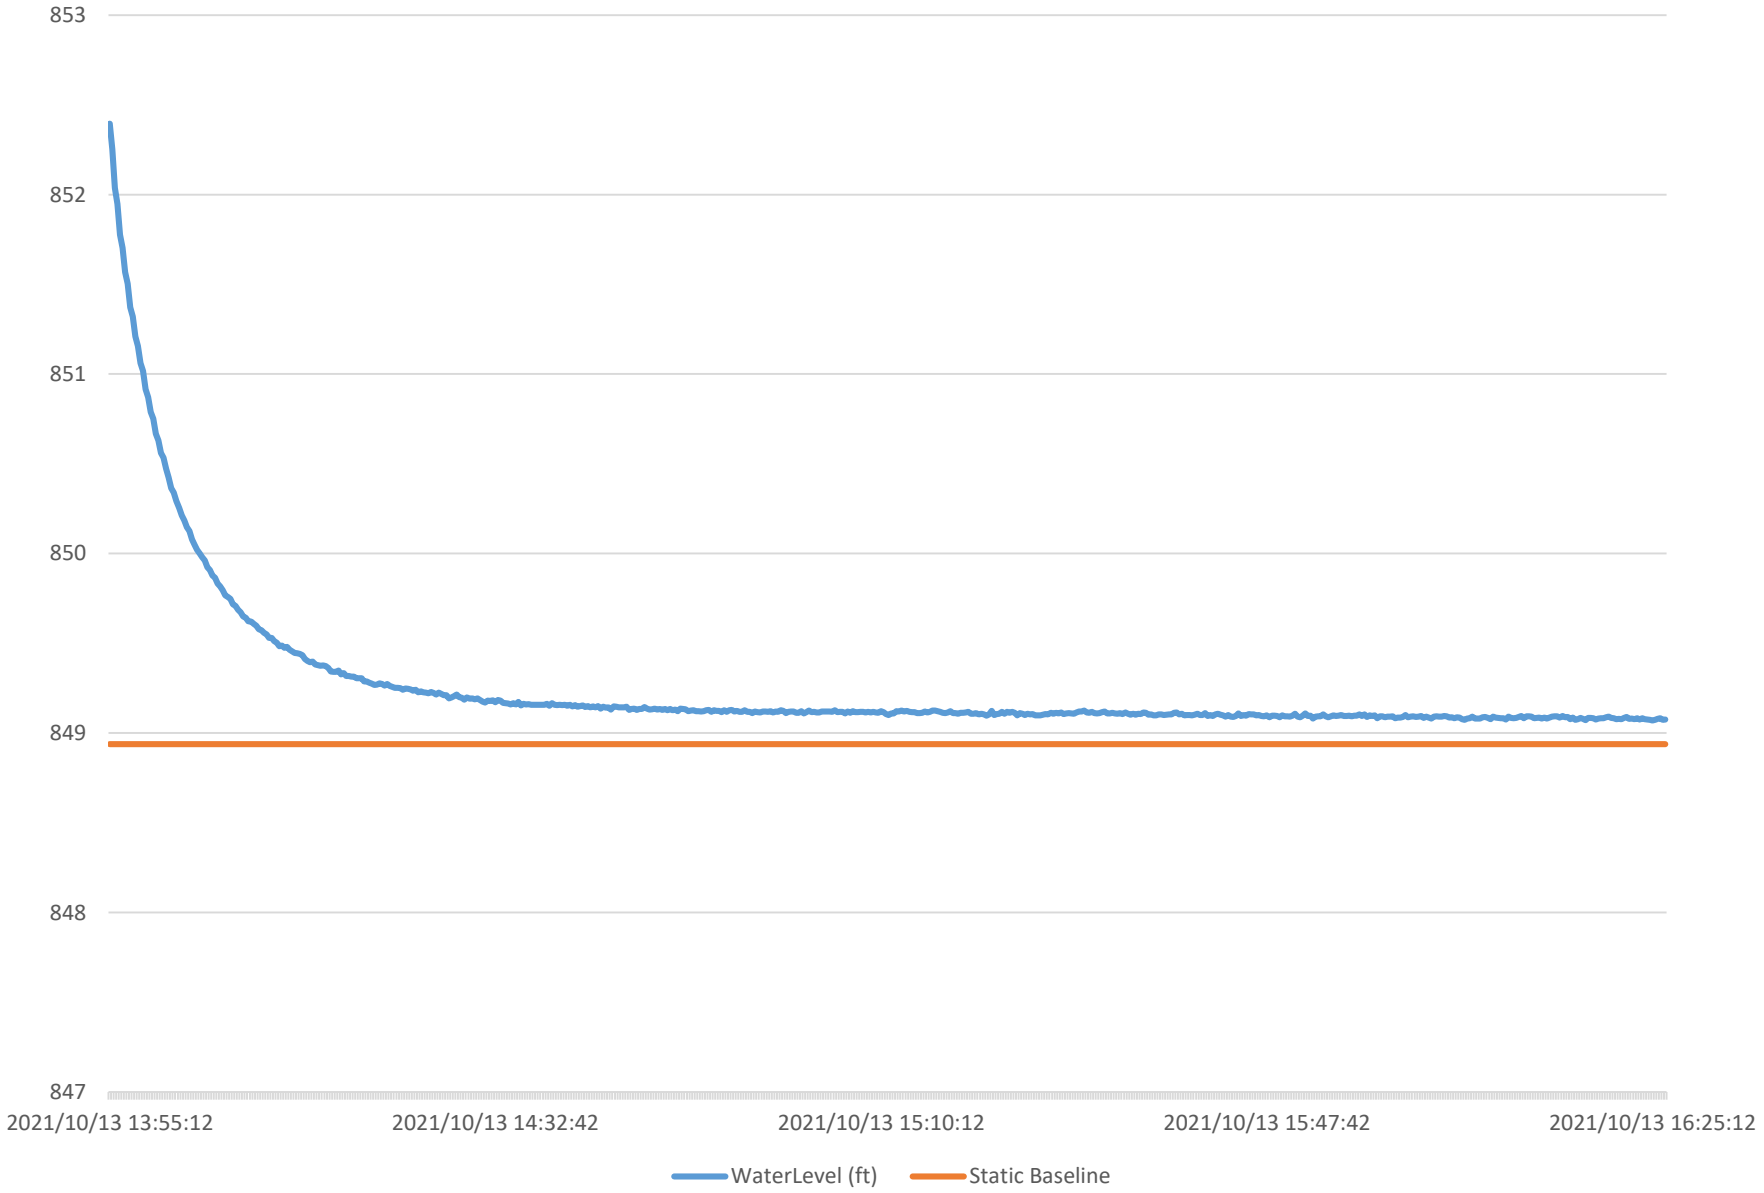
FIGURE ____
SLUG TEST DATA
MW-4
Exide Technologies
Frankfort, Indiana

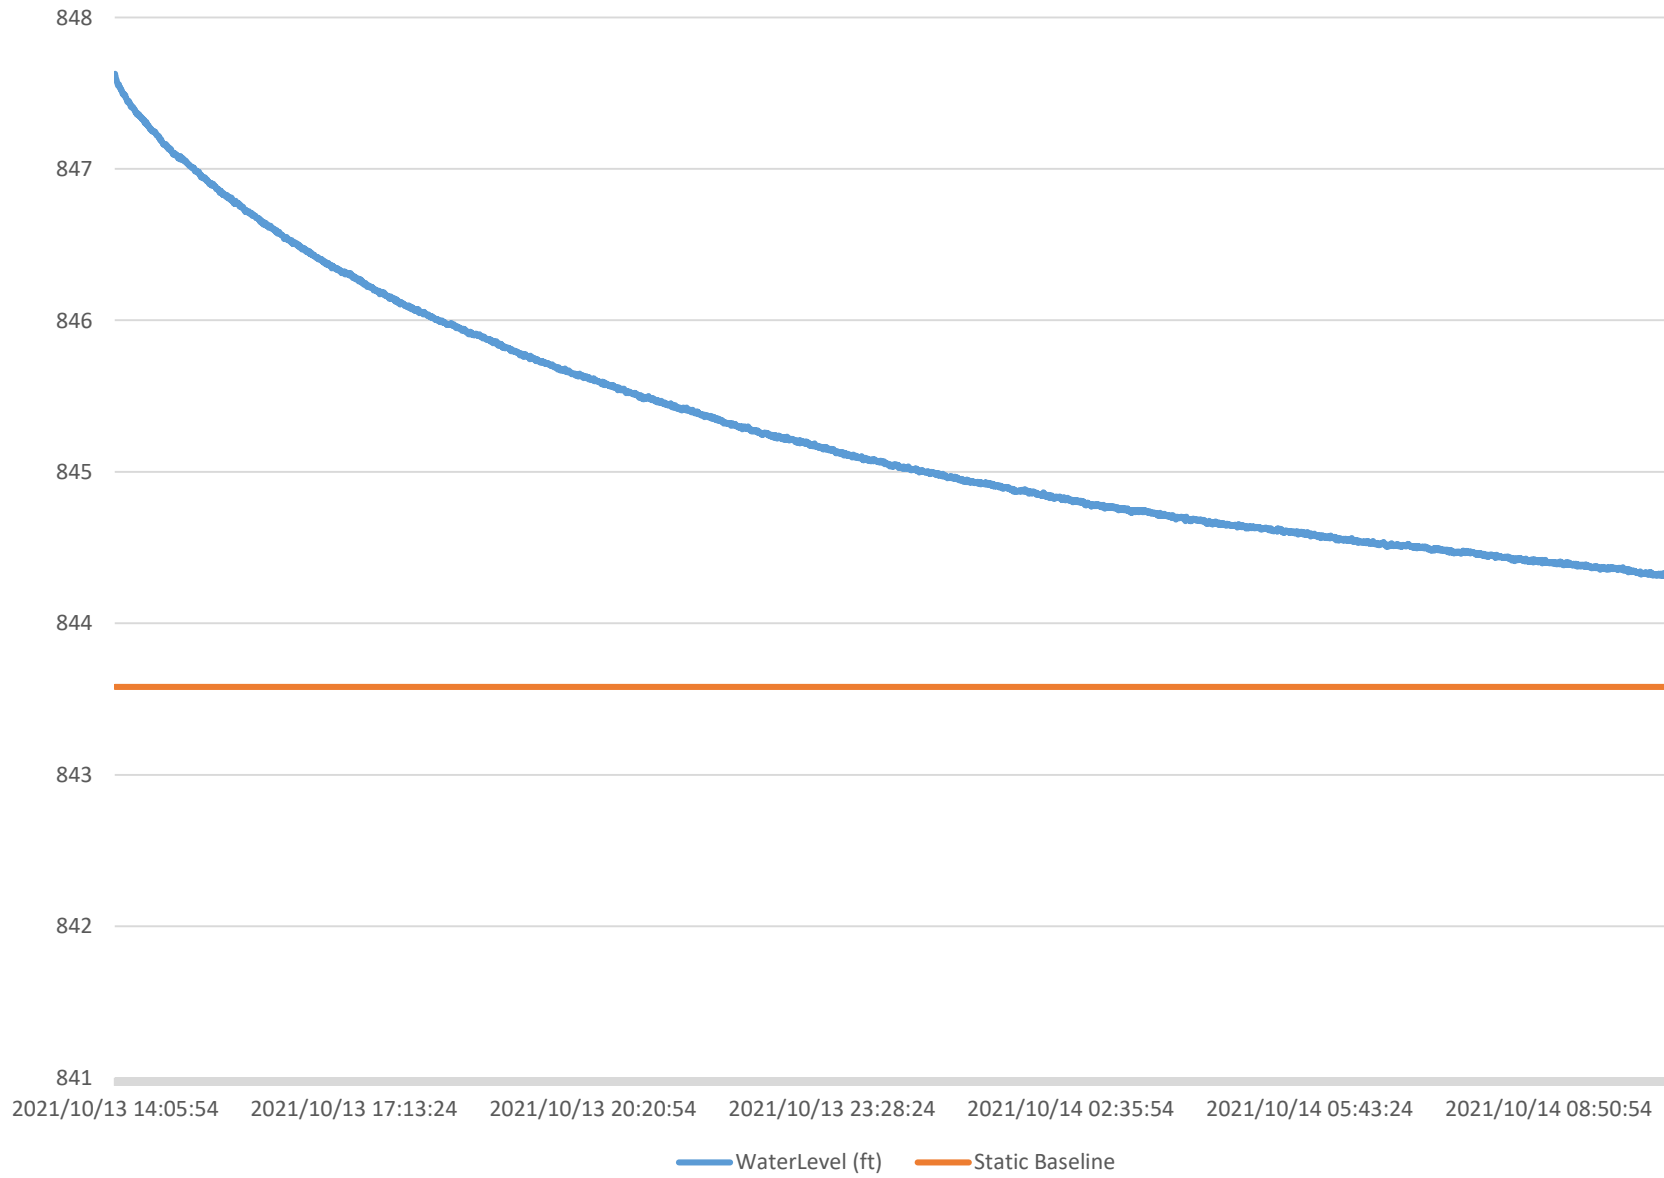
COMPUTED	
L_{wetted}	7.77 Feet
D	489.77 Feet
H	7.77 Feet
L/r_w	22.60
Y_0 -DISPLACEMENT	10.15 Feet
Y_0 -SLUG	12.25 Feet
From look-up table using L/r_w	
Partial penetrate A	2.291
B	0.366
$\ln(Re/r_w)$	1.814
Re	2.11 Feet
Slope	$2.51E-06 \log_{10}/\text{sec}$
$t_{90\%}$ recovery	397837 sec
Input is consistent.	
K = 0.0004 Feet/Day

FIGURE ____
SLUG TEST DATA
MW-7
Exide Technologies
Frankfort, Indiana

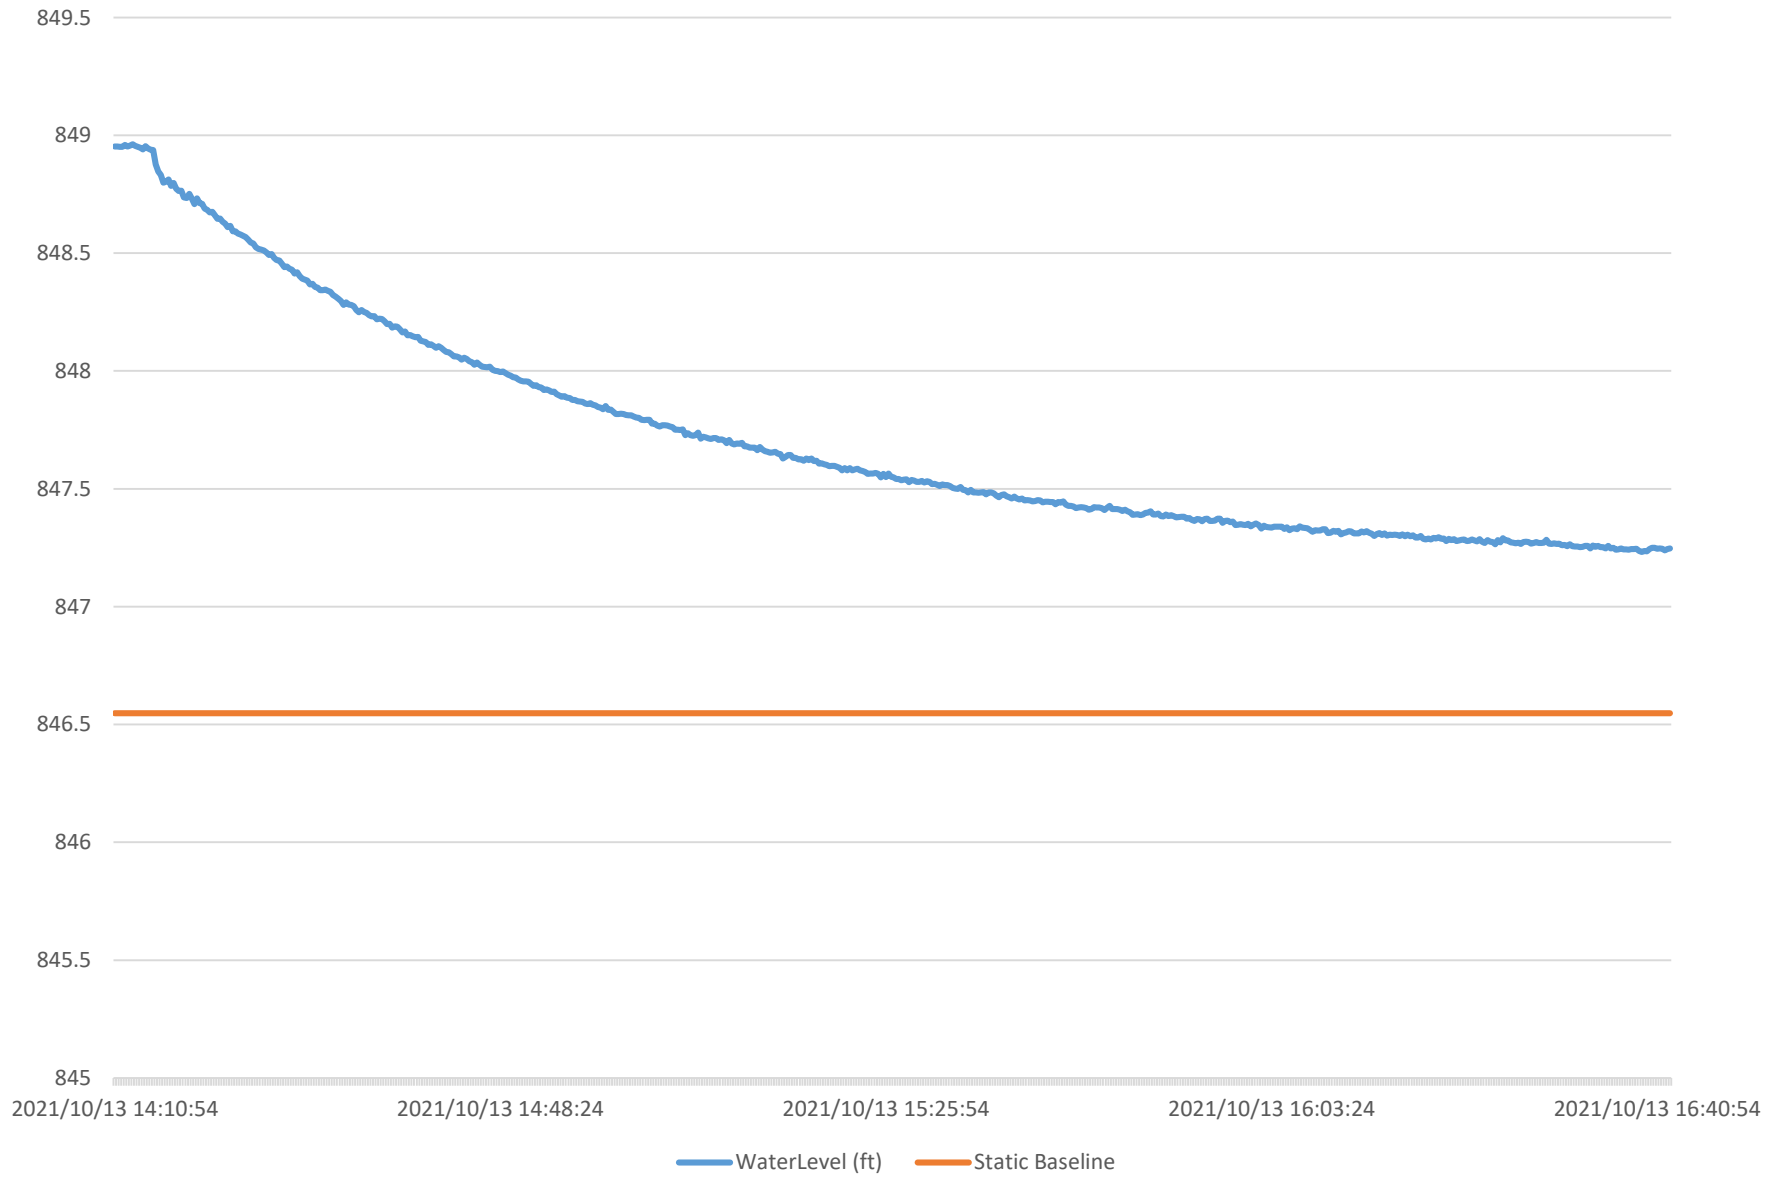
FIGURE ____
SLUG TEST DATA
MW-9
Exide Technologies
Frankfort, Indiana

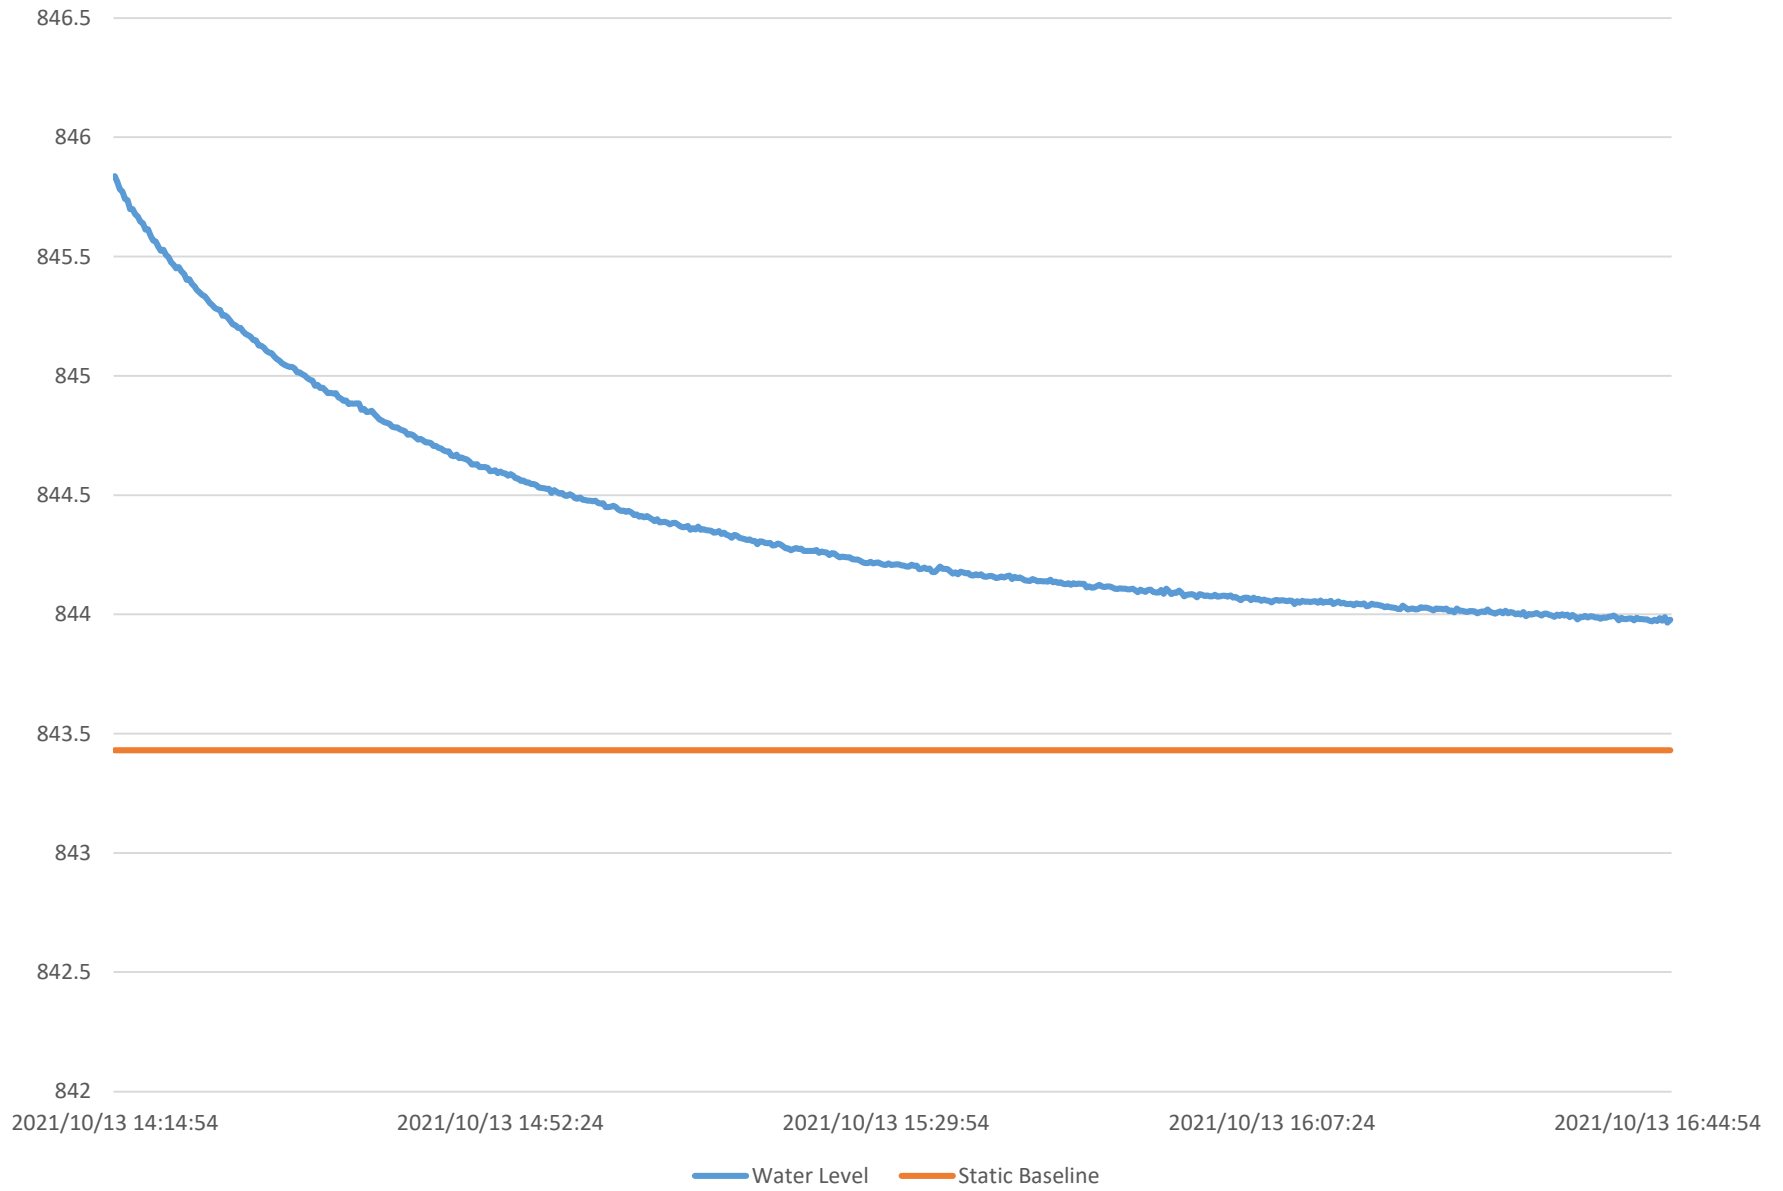
FIGURE ____
SLUG TEST DATA
MW-10
Exide Technologies
Frankfort, Indiana

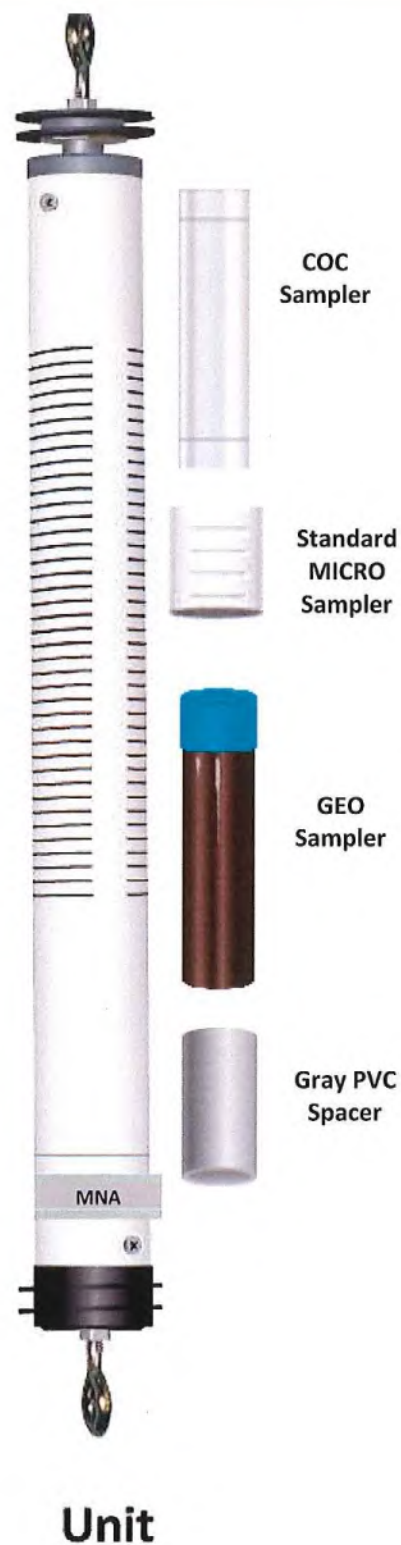
- Twist off the bottom of unit labeled "MNA" to fill with samplers.
- First, place the COC Sampler in the housing unit.
- Next, insert the Standard MICRO sampler. It does not matter which end goes in first. Be sure to wear gloves.
- Then, place the 40 mL amber VOA vial with the **Teal screw cap** (GEO Sampler) into the housing so that the cap is facing the MICRO sampler and the top of the unit.
- Please insert one gray PVC spacer as a substitute for an amendment supplier.
- Hand-tighten the threaded cap back onto unit until it is secure. Remember to store the unit in an upright position.
- A total of three (3) units of this configuration will be required.

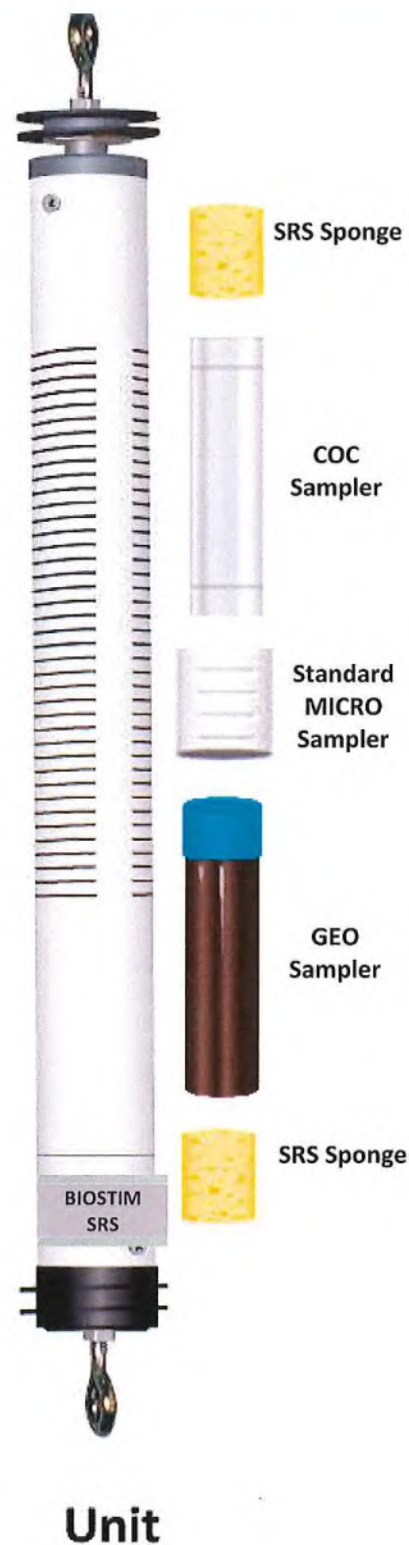
Bio-Stim – SRS

- Twist off the bottom of unit labeled “BIOSTIM SRS” to fill with samplers.
- First, place one of the SRS amendment supplier sponges into the unit.
- Then, place the COC Sampler in the housing unit.
- Next, insert the MICRO sampler. It does not matter which end goes in first.
Be sure to wear gloves.
- Next, place the 40 mL VOA vial with the **Teal screw cap** (GEO Sampler) into the housing so that the cap is facing the MICRO sampler and the top unit.
- Next, insert another SRS amendment supplier sponge into the unit.
- Carefully hand-tighten the threaded cap back onto unit until it is secure. Remember to store the unit in an upright position.
- A total of three (3) units of this configuration will be required.

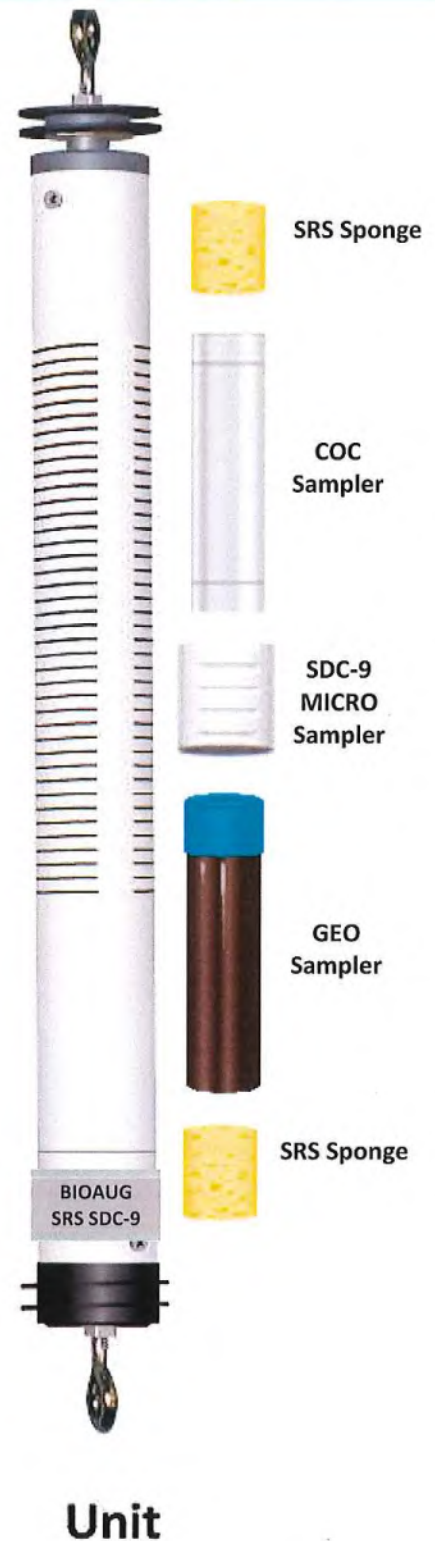
Bio-Aug – SRS, SDC-9 culture

- Twist off the bottom of unit labeled “**BIOAUG** SRS SDC-9” to fill with samplers.
- First, place one of the SRS amendment supplier sponges into the unit.
- Then, place the COC Sampler in the housing unit.
- Next insert the SDC-9 MICRO sampler. It does not matter which end goes in first.
Be sure to wear gloves.
- Next, place the 40 mL VOA vial with the **Teal screw cap** (GEO Sampler) into the housing so that the cap is facing the MICRO sampler and the top unit.
- Next, insert another SRS amendment supplier sponge into the unit.
- Carefully hand-tighten the threaded cap back onto unit until it is secure. Remember to store the unit in an upright position.
- A total of three (3) units of this configuration will be required.

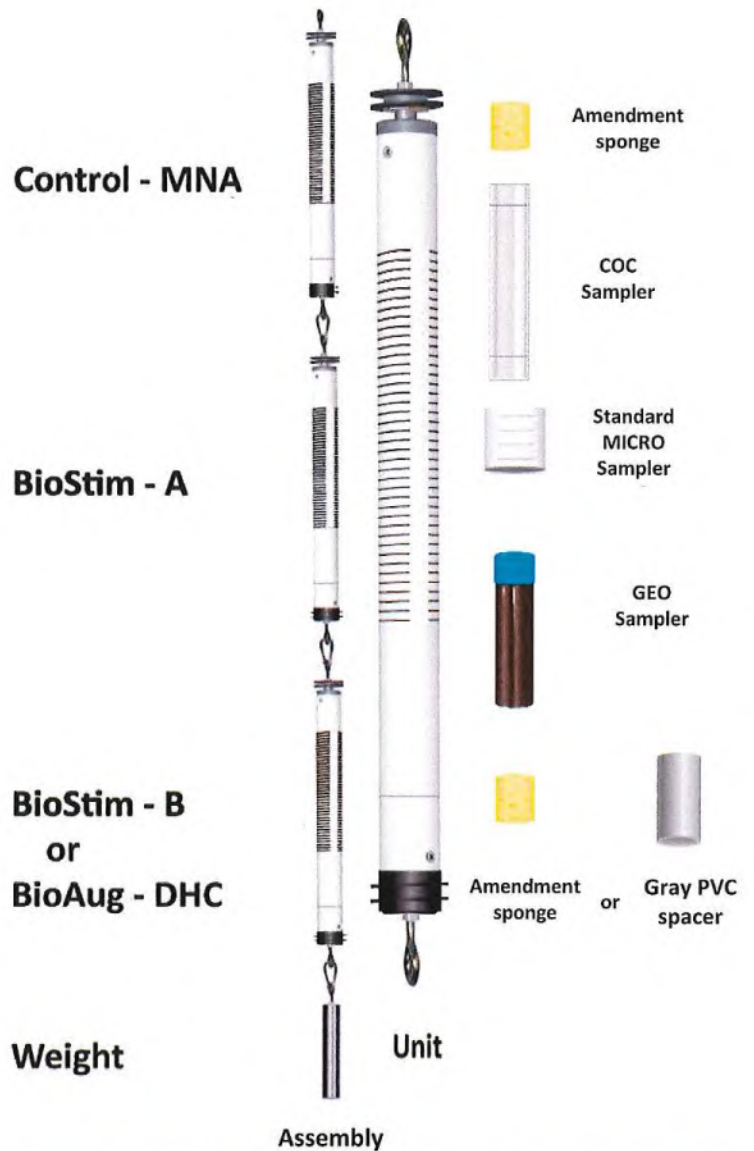
Illustration of Bio-Trap Assembly, Unit, and Samplers. Actual configuration may vary depending on the number of units per well

In addition to the CENSUS analysis, Bio-Trap[®] samplers also collect groundwater for characterization of secondary lines of evidence indicative of microbial growth and contaminant degradation including dissolved gas production (ethane, ethene and methane), volatile fatty acids (“VFA”) production, standard geochemical parameters and contaminant of concern concentration profiles. Detection of VFAs indicates active fermentation of intrinsic or added organic substrates (i.e. biostimulation) by microbial organisms has occurred and microbial growth is favorable. Changes to the innate contaminant of concern concentration profile, with the production of intermediate degradation products (e.g., cis-1,2,-Dichloroethene and vinyl chloride) and non-toxic end products (e.g., ethene and ethane), can provide a direct line of evidence that bioremediation is occurring. Lastly, the Bio-Trap[®] sampler includes sub-units that assess the benefit of carbon substrate addition, a critical factor in determining full-scale design parameters. The following text is an excerpt from the SITE LOGIC Report dated March 25, 2022, and briefly describes each sub-unit that was deployed in MW-1, MW-4, and MW-9 on December 10, 2021:

Monitored Natural Attenuation (MNA) Unit: *The purpose of the Control Bio-Trap Unit is to quantify contaminant degrading bacteria and daughter product formation under monitored natural attenuation (MNA) conditions and to serve as a baseline for comparison to BioStim and/or BioAug Units.*

BioStim Slow Release Substrate (SRS) Unit: *The Biostimulation Bio-Trap Unit is designed to test the hypothesis that electron donor addition will stimulate growth of dechlorinating bacteria and enhance biodegradation.*

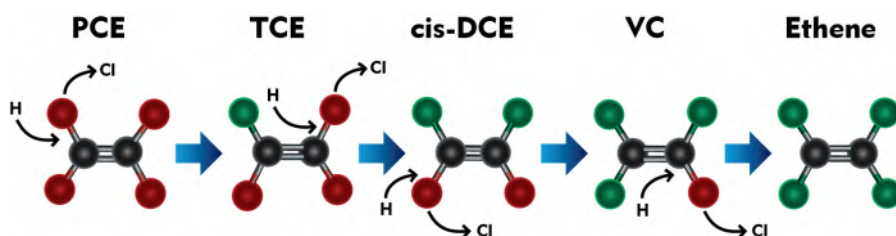
Under anaerobic conditions, tetrachloroethene (PCE) and trichloroethene (TCE) can undergo sequential reductive dechlorination through the daughter products *cis*-dichloroethene (*cis*-DCE) and vinyl chloride to nontoxic ethene (1,2).

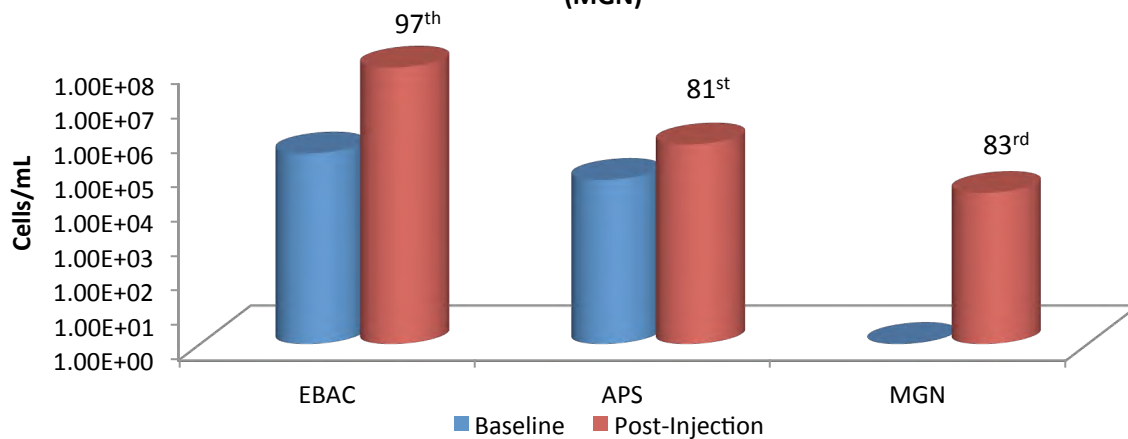
Figure 4: Total Bacteria (EBAC), Sulfate Reducing Bacteria (APS) and Methanogens (MGN)
